INVITATION FOR BID (IFB)

IFB Reference Information:	Sinkhole Structural Repairs		
Insured Property Owner:	Alachua County Library District		
Property Location Name:	Storage Warehouse		
Address Line 1:	3145 NW 43rd Street		
Address Line 2:	Enter Text Here		
City:	Gainesville	State:	Florida Zip Code: 32606

Final Report: Structural Damage Assessment Geotechnical Evaluation

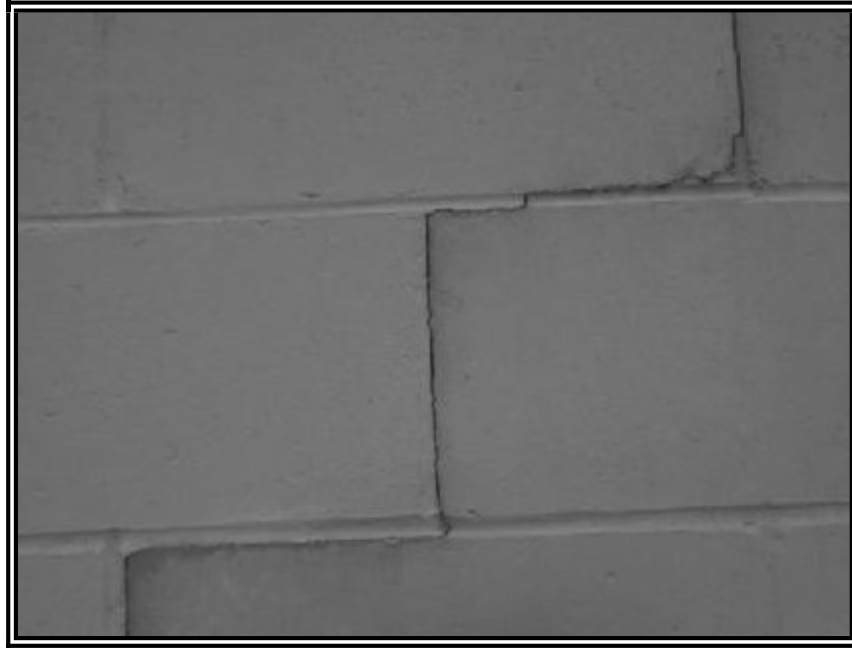
Photograph 3

- Various hairline to 1/16-inch-wide horizontal, vertical, and stair-stepped cracks were observed in the CMU perimeter wall surfaces. The most predominate stair stepped crack was located near the south end of the wall section (**photograph 3**).

View of damage in the west wall.

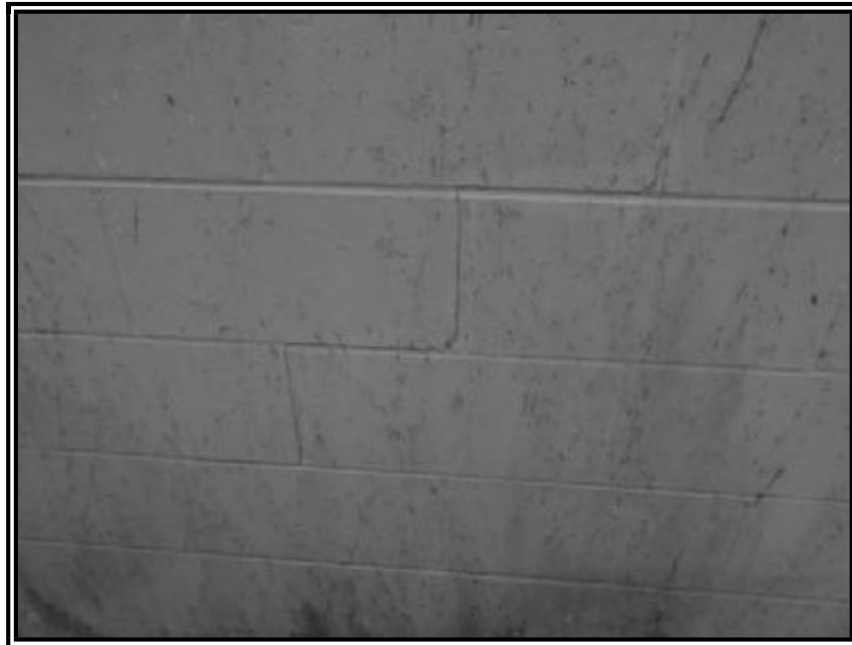
Photograph 4

- Various hairline to 1/32-inch-wide horizontal, vertical, and stair-stepped cracks were observed in the CMU perimeter wall surfaces. The most predominate cracks were found in the center part of the wall (**photograph 4**).

View of damage in the south wall.

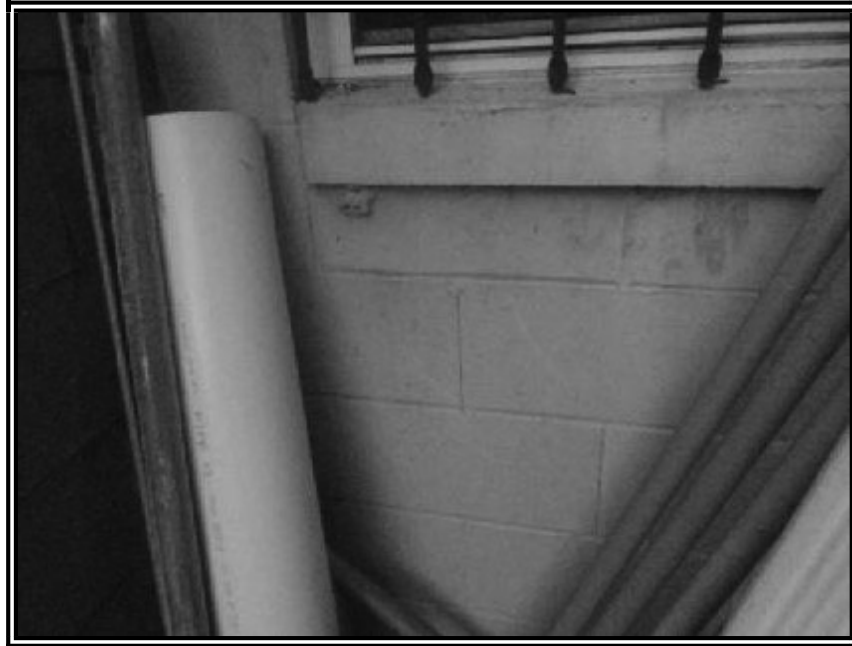
Photograph 5

- Various hairline to 1/32-inch-wide horizontal, vertical, and stair-stepped cracks were observed in the CMU perimeter wall surfaces (**photograph 5**).

View of damage in the east wall.

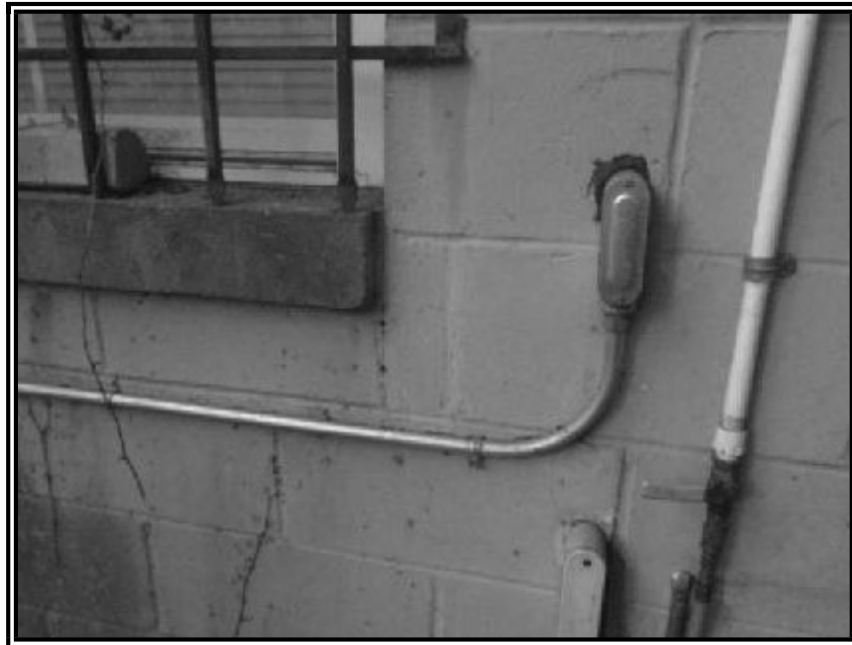
Photograph 6

- Various hairline to 1/32-inch-wide horizontal, vertical, and stair-stepped cracks were observed in the CMU perimeter wall surfaces (**photograph 6**).

View of damage in the north wall.

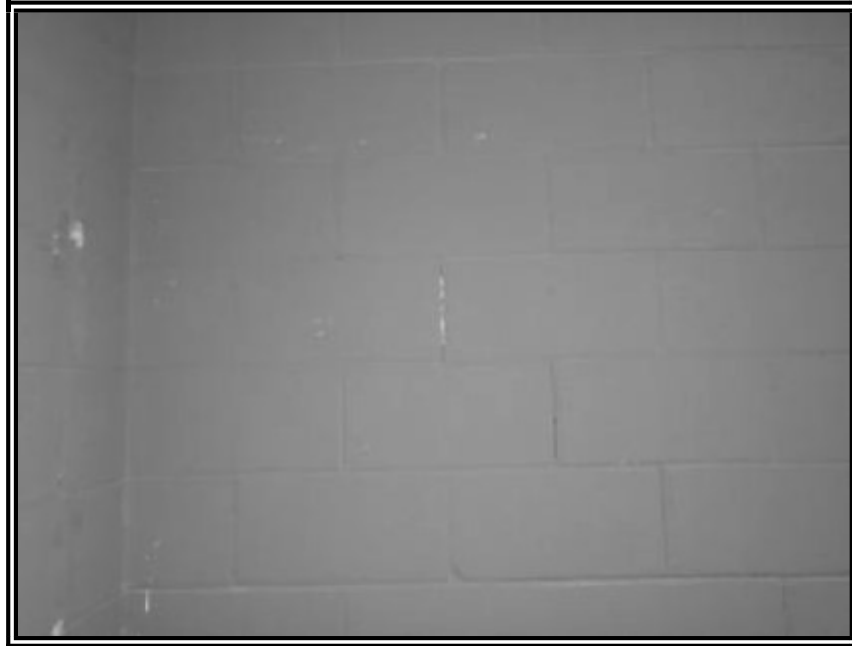
Photograph 7

- Southwest storage room: various hairline to 3/32-inch-wide horizontal, vertical, and stair-stepped cracks were observed in the exposed CMU perimeter wall surfaces (**photograph 7**), which matched the exterior crack(s).
- Various hairline to 1/4-inch-wide horizontal and vertically oriented cracks were observed in the surfaces of the concrete floor slab-on-grade [**REASON FOR THE CLAIM**] (**photographs 8 through 10**), and various hairline to 5-inch-wide separations were observed along the wall/ceiling and wall/wall joints of the main office and restroom areas located in the northeast quadrant of the structure [**REASON FOR THE CLAIM**] (**photographs 11 through 13**).

View of interior CMU damage at the southwest corner looking east.

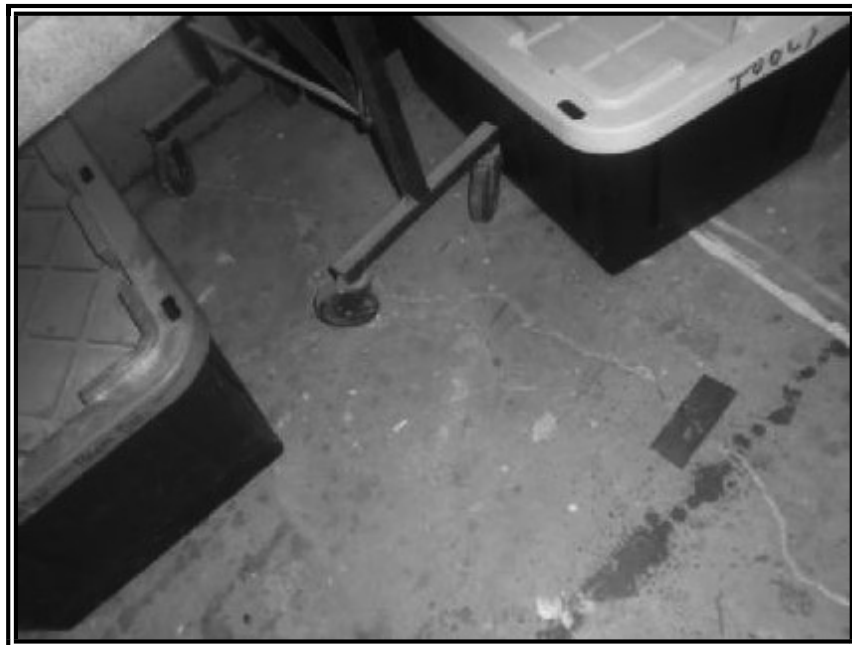
Photograph 8

View of interior floor damage [REASON FOR THE CLAIM].

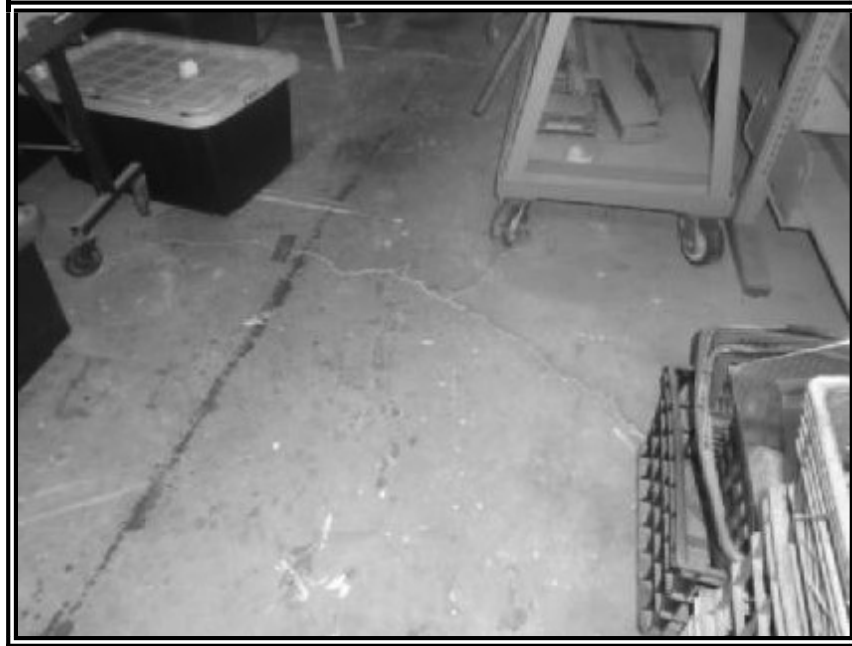
Photograph 9

View of interior floor damage [REASON FOR THE CLAIM].

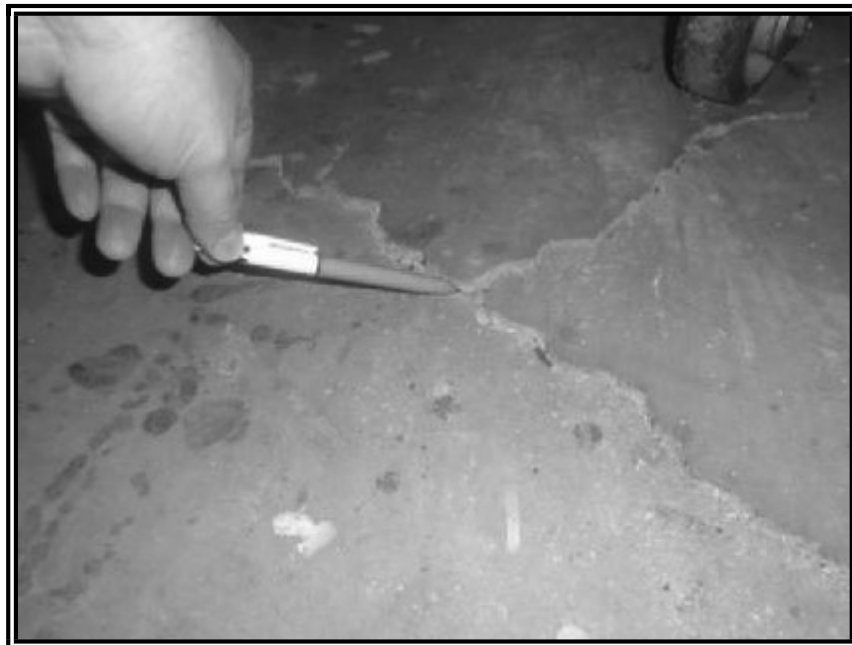
Photograph 10

View of interior floor damage [REASON FOR THE CLAIM].

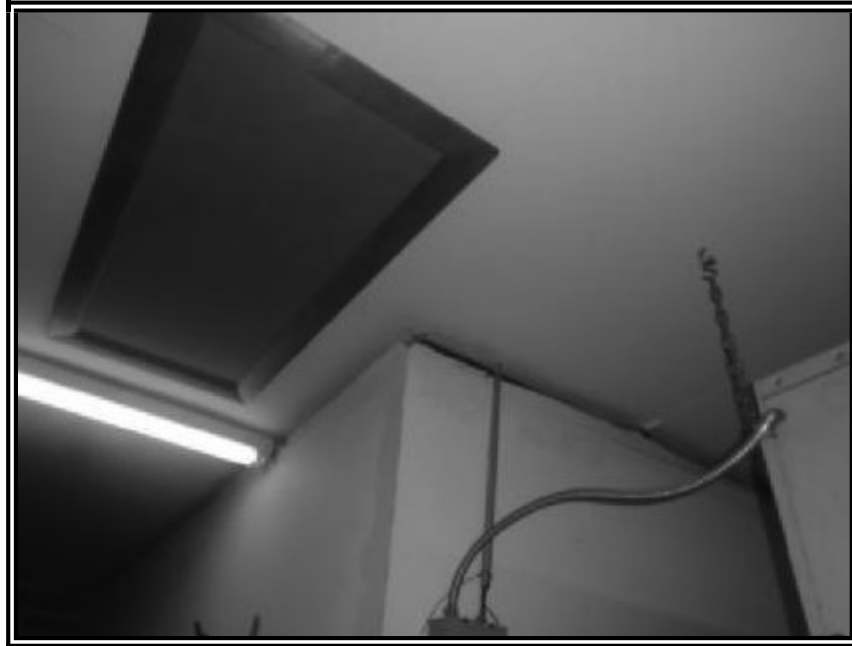
Photograph 11

View of damages in maintenance office [REASON FOR THE CLAIM].

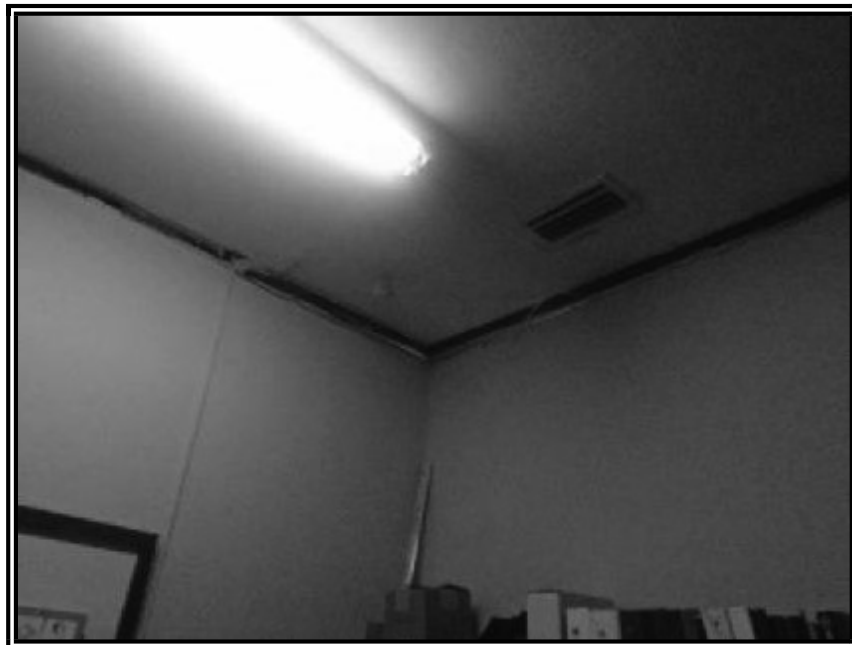
Photograph 12

View of damages in maintenance office [REASON FOR THE CLAIM].

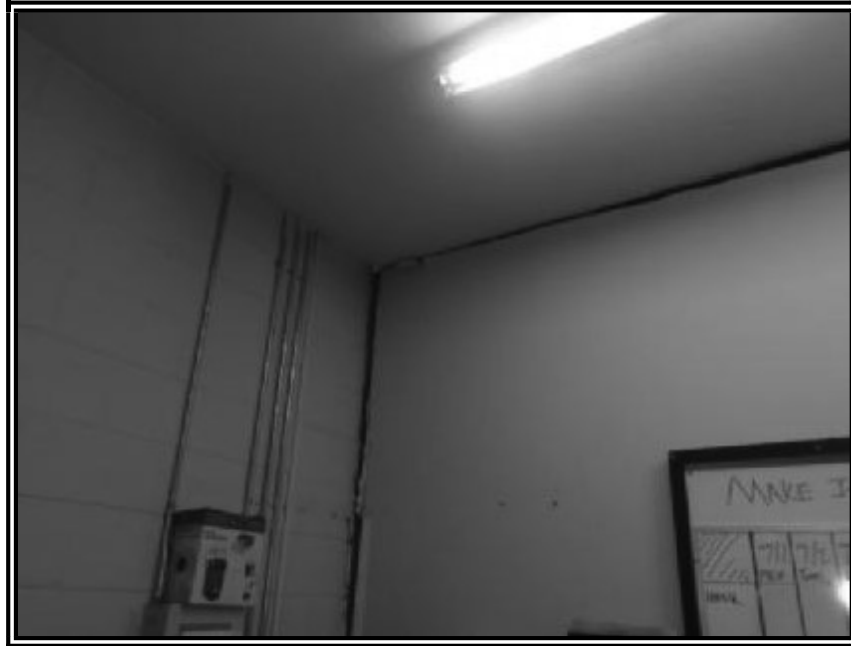
Photograph 13

View of damages in maintenance office [REASON FOR THE CLAIM].
