GC2018092556-6992-5153: McKenzie House – Demo

LOCATION: McKenzie House | 17 E. 3rd Ct., Panama City, FL 32401

IHC - Moisture and Mold Evaluation Report

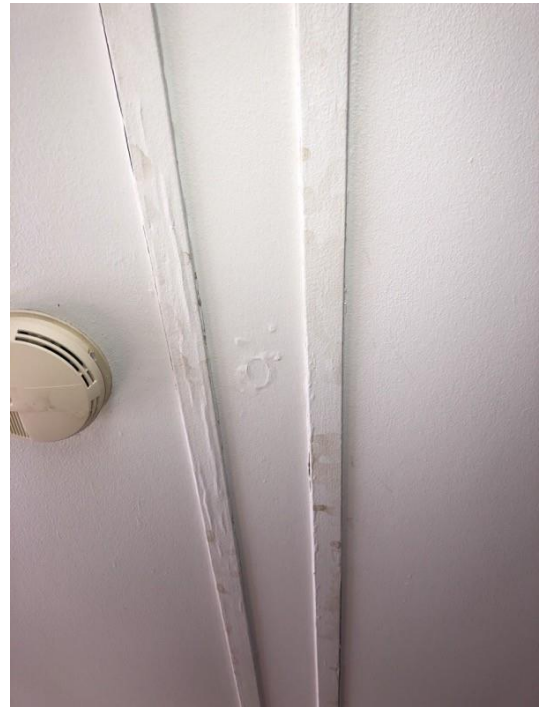
Photo Description Rm 1 visual water damage on walls and ceiling

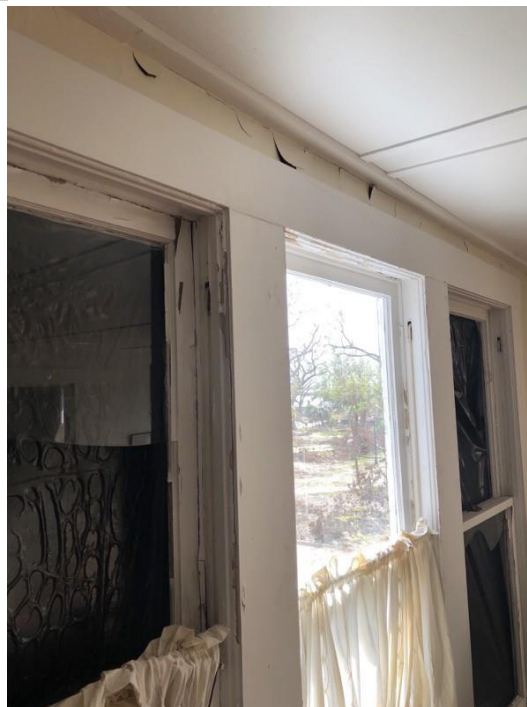
Upstairs hallway visible mold growth and water damage on ceiling

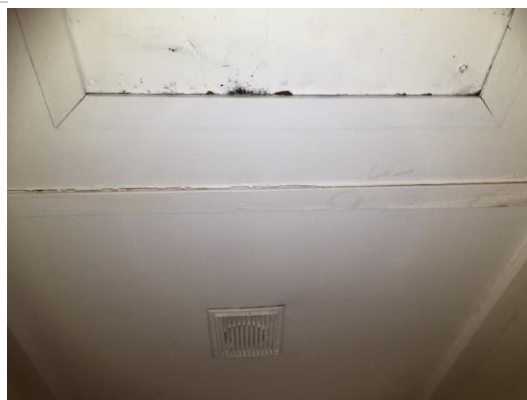
Additional photo for room 1

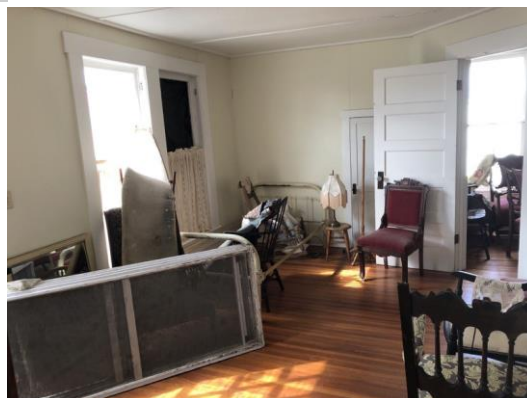
Room 2 visible mold growth and water damage on ceiling

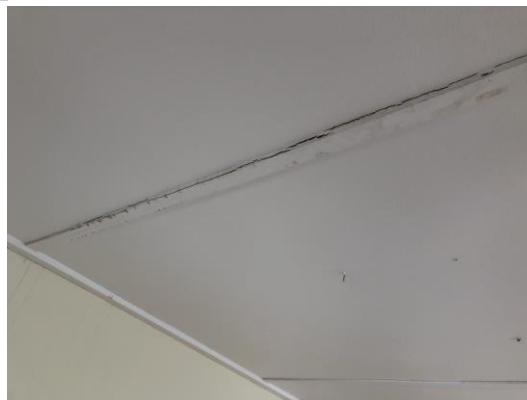
Upstairs foyer visible water damage on ceiling

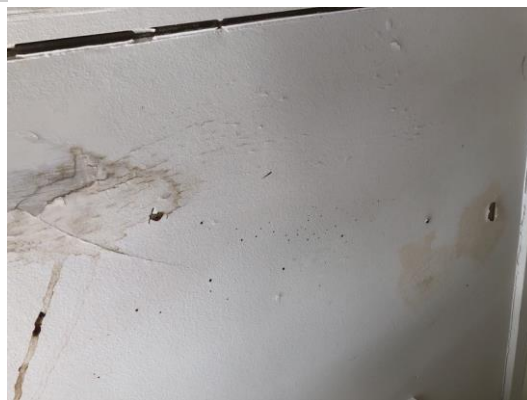
Additional photo for upstairs foyer visible water damage to ceiling and walls

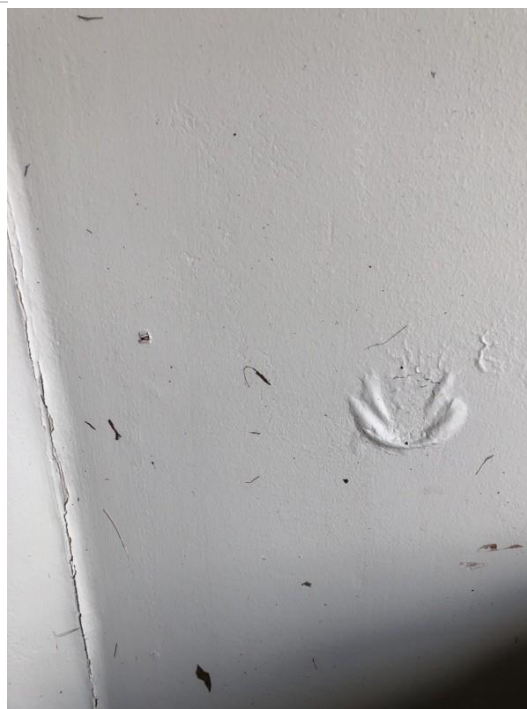
Additional photo for upstairs hallway
visual water damage

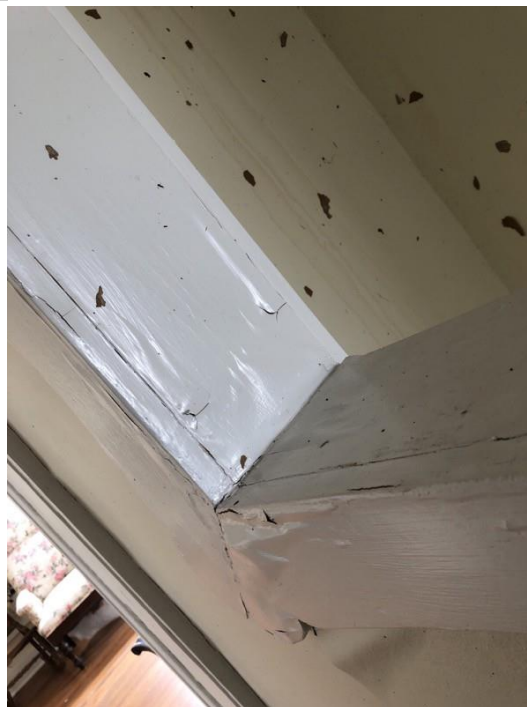
Additional photo for upstairs hallway .

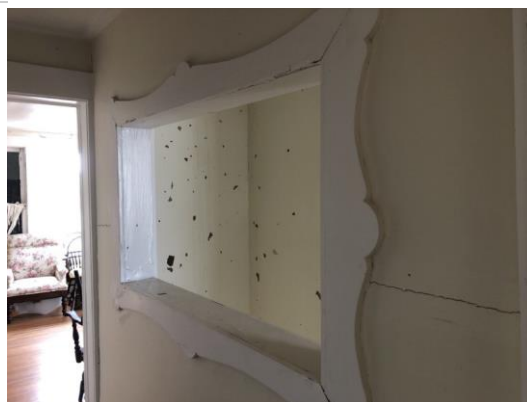
Top of stairwell Visual water damage and visual mold growth

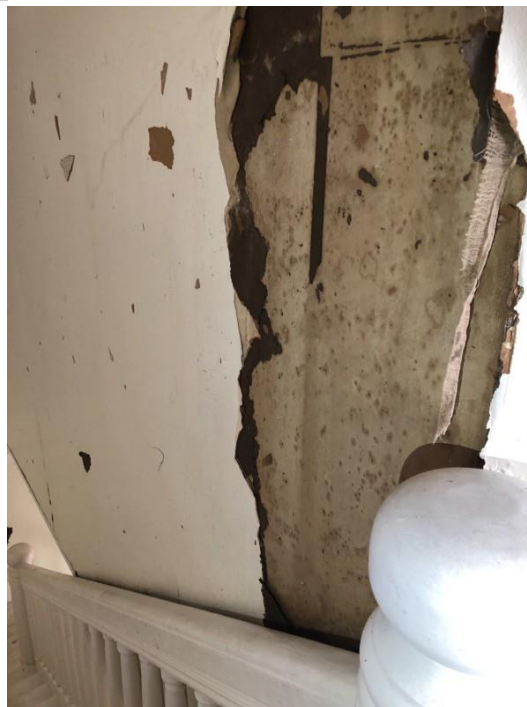
Stairwell walls with visible water damage

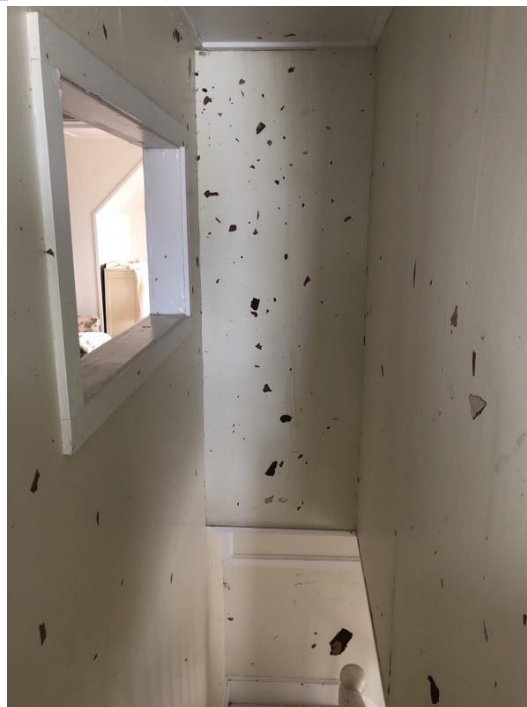
Stairs with visible water damage

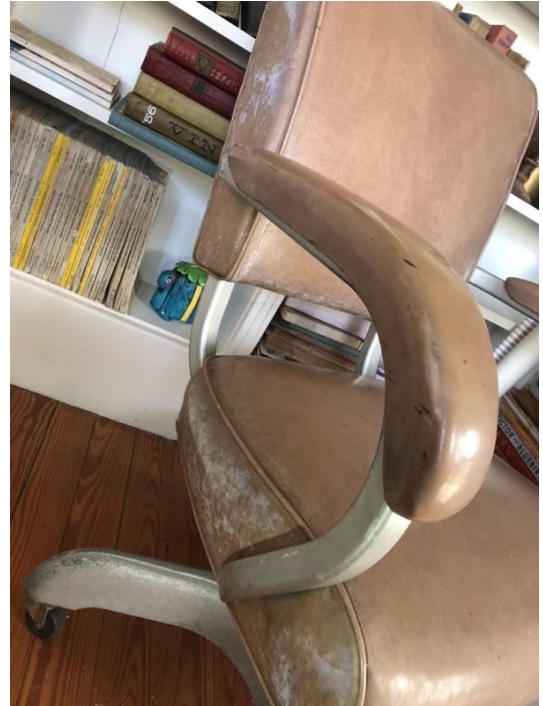
Library chair number three visual water damage and visual mold growth

The porous or soft contents with visual mold growth present should be removed and disposed of. Any hard surface or non-porous contents including finished furnishings, plastics, glass, stainless steel, chairs, desks, etc. and related should be surface cleaned using HEPA vacuuming techniques and wet wiping techniques then should be treated or sprayed with an approved disinfectant.

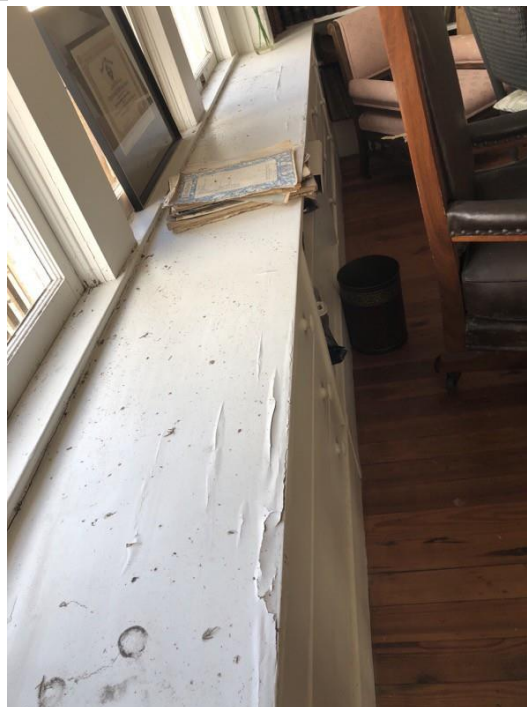
Library sealing visual water damage

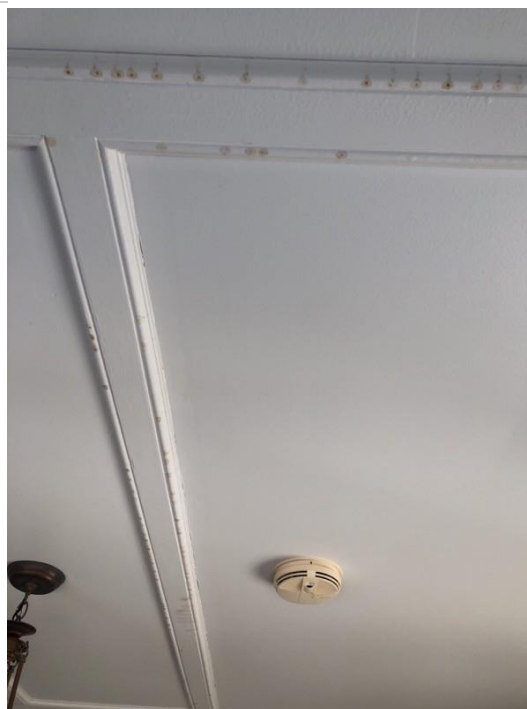
Additional photo for library ceiling visual water damage and mold growth

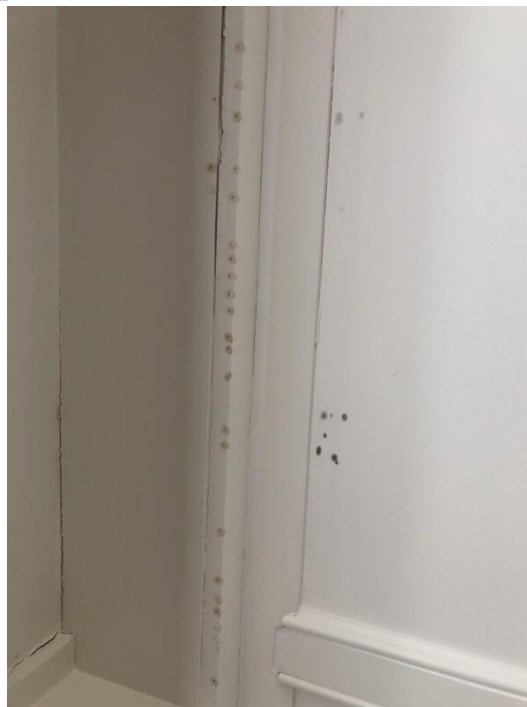
Dining room visual water damage to ceiling and walls

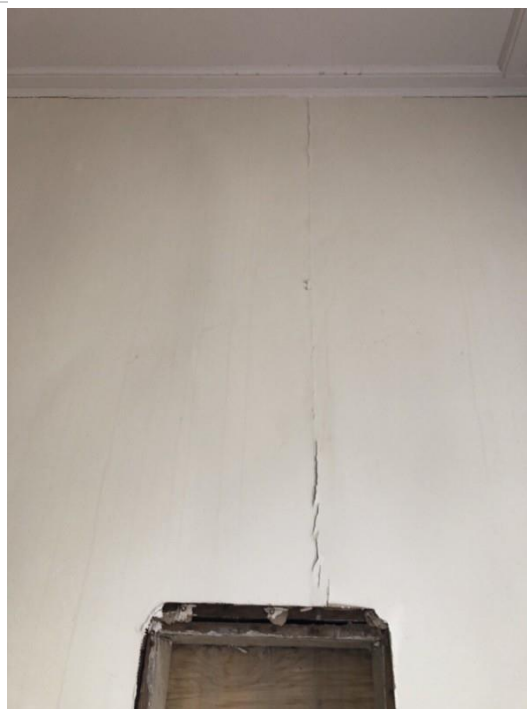
Dining room visual water damage and mold growth

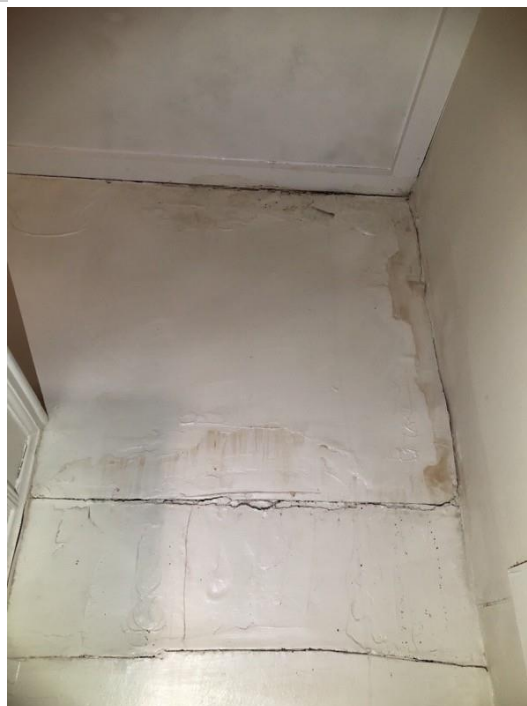
Additional photo for downstairs bathroom

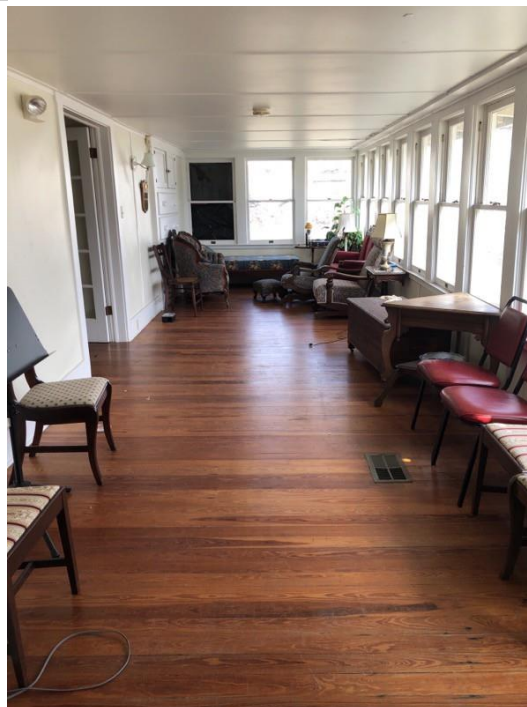
Sunroom visual water damage to ceiling

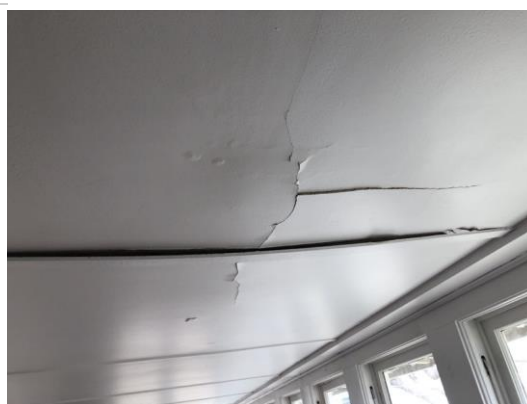
Sunroom visual water staining on sealing

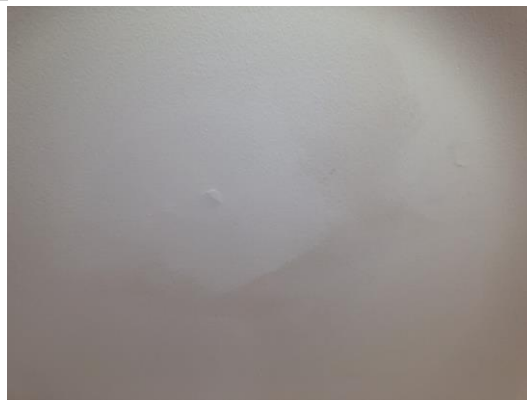
Sunroom additional photo visual water damage to ceiling

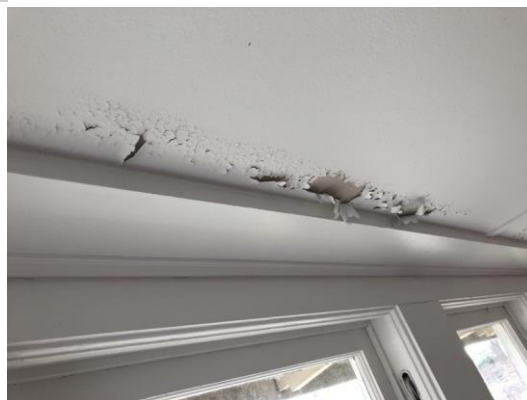
Sunroom visual water damage on walls

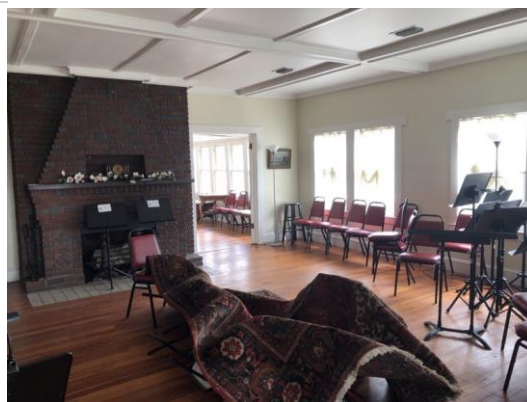
Fireplace room visual water damage to ceiling

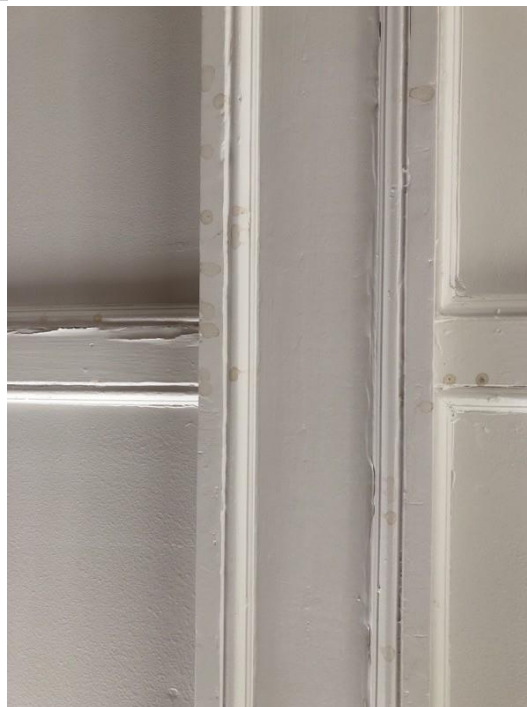
Fireplace room visual water damage to ceiling.

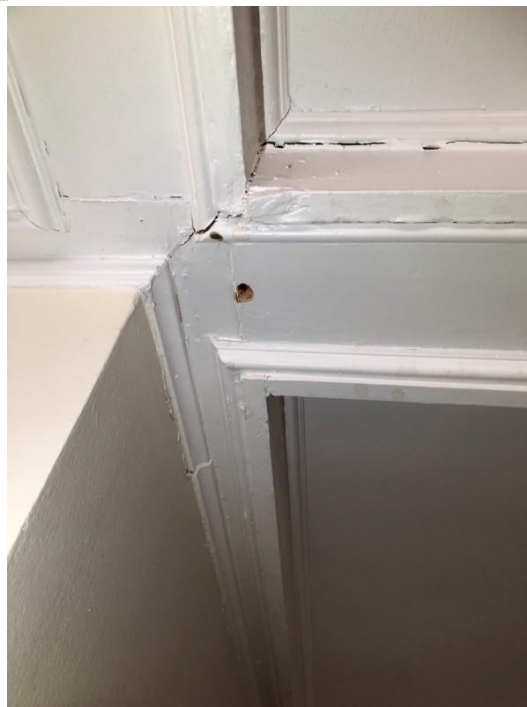
Fireplace room visual water damage to walls

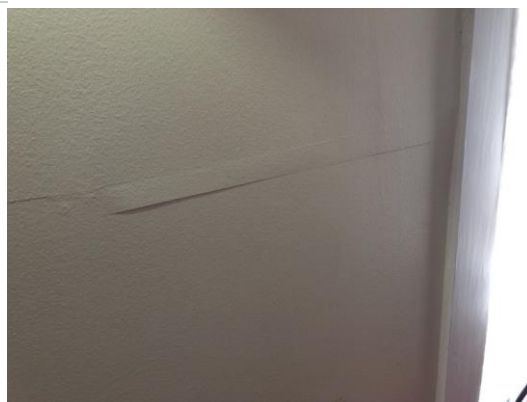
Entryway staircase visual water damage and mold growth

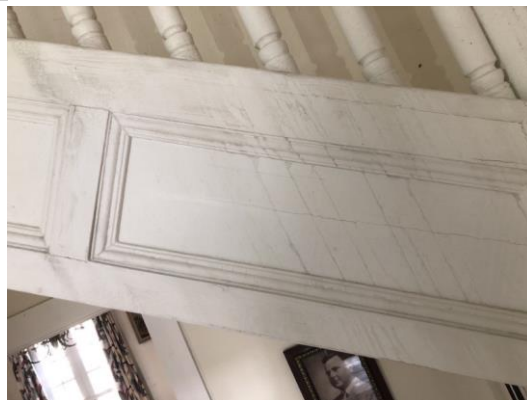
Main entryway ceiling visual water damage

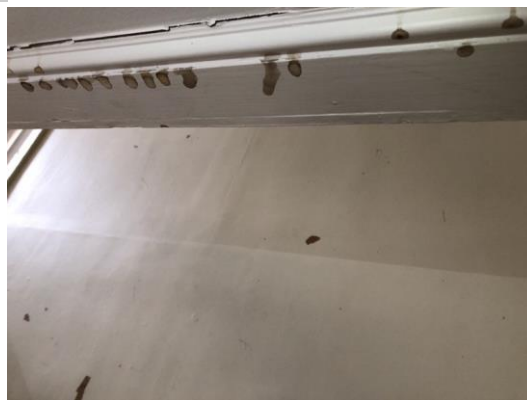
Above main entryway visual water damage

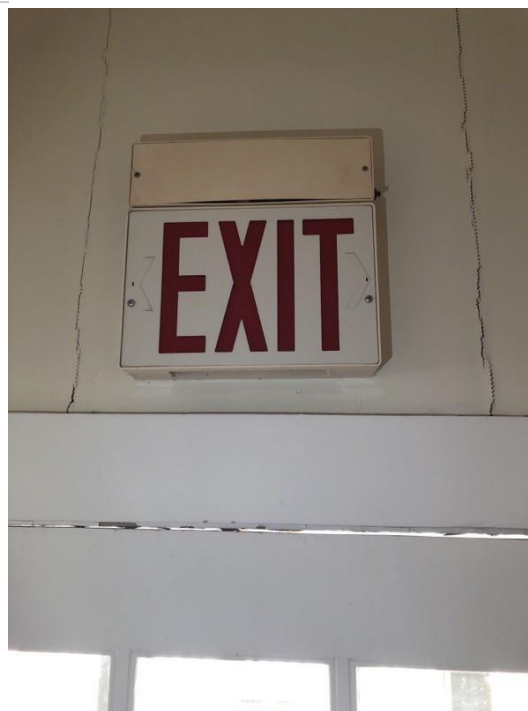
Main entryway visual mold growth and water damage on wood flooring

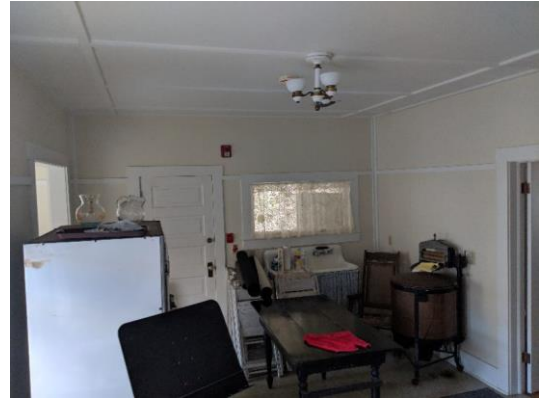
Dining area. Walls and ceiling are damaged

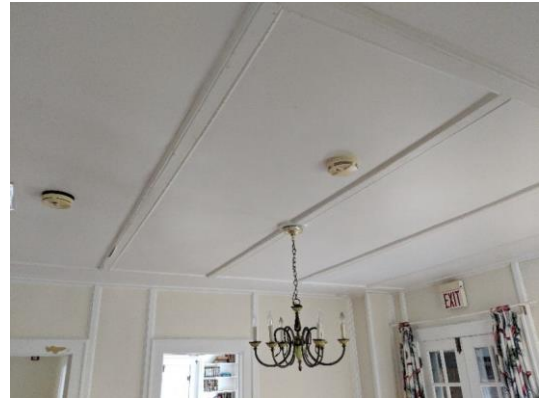
Living room space with water damage to ceiling

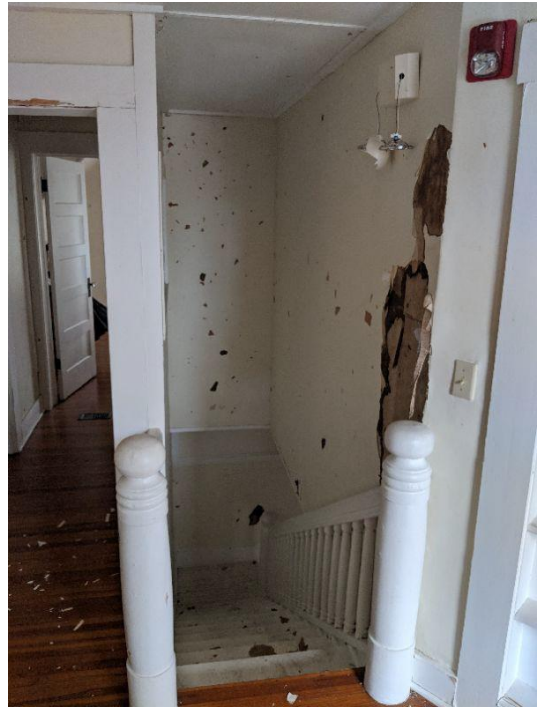
Upper level landing with water damage to walls and ceiling

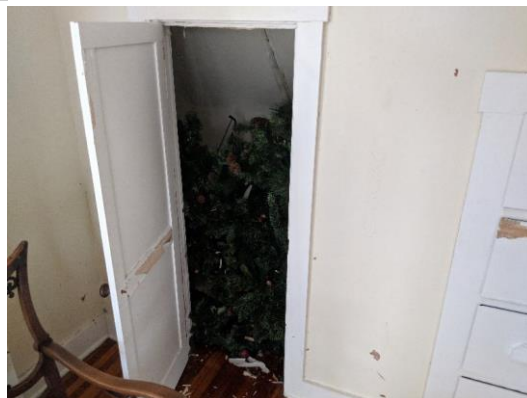
Upper level bedroom closet with water damage

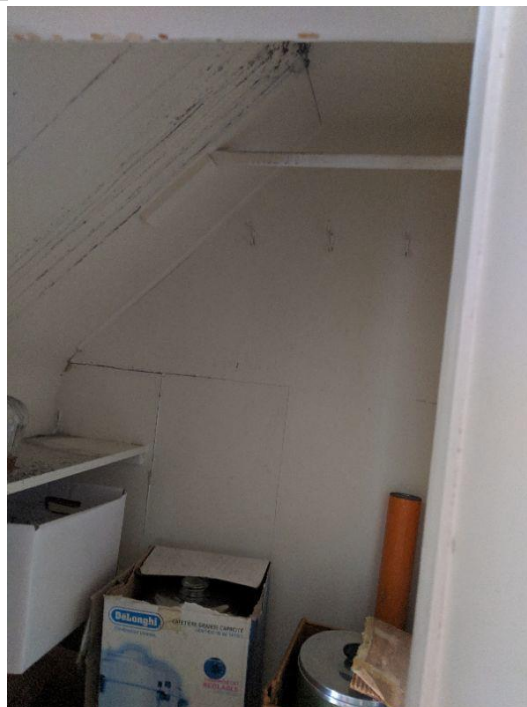
Upper level bedroom with water damage to ceiling

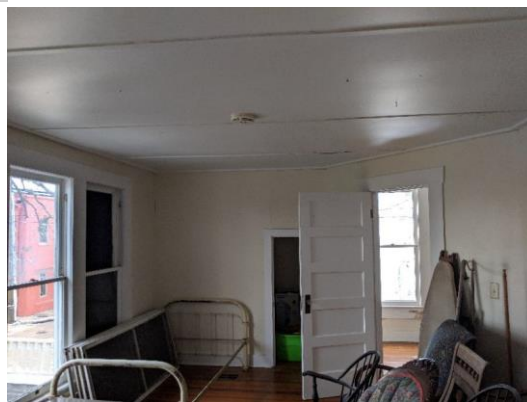
Upper level bedroom. Waterdamage noted to exterior walls
