INVITATION FOR BID (IFB)

IFB Reference Information:	Mold Remediation and Demolition			
Insured Property Owner:	City of Caldwell			
Property Location Name:	City Hall (Under Construction)			
Address Line 1:	102 E. Fox Street			
Address Line 2:	-			
City:	Caldwell	State:	Texas	Zip Code: 77836

Created: Mon 22 Mar 19:27 2021
Location: Caldwell City Hall
Title: Moisture And Water Damage Evaluation-Scope
No. Items: 68

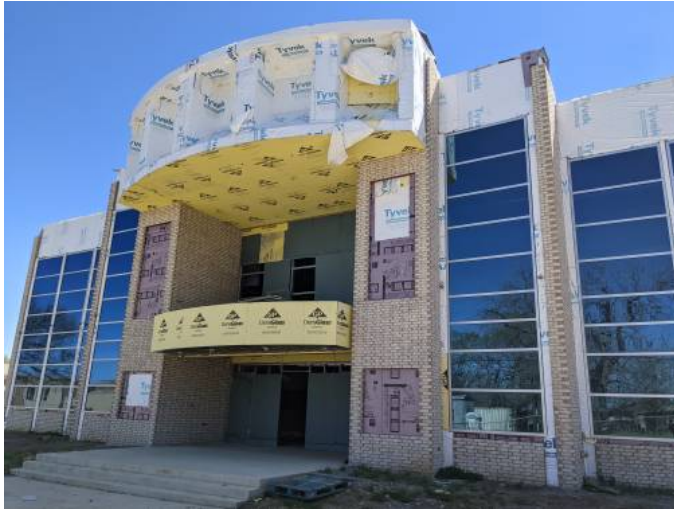
(1)

Front of city hall building located along the lower elevation (primary water impacted building).

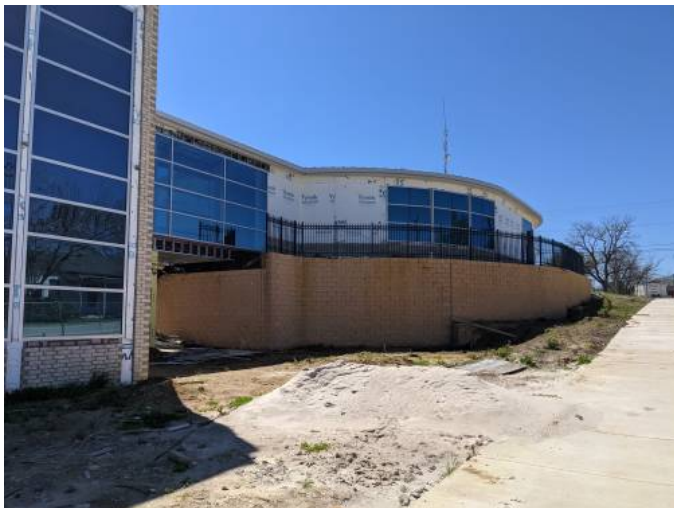
(2)

View of the attached city hall building along the upper elevation of the property. This building was minimally impacted by water damage.

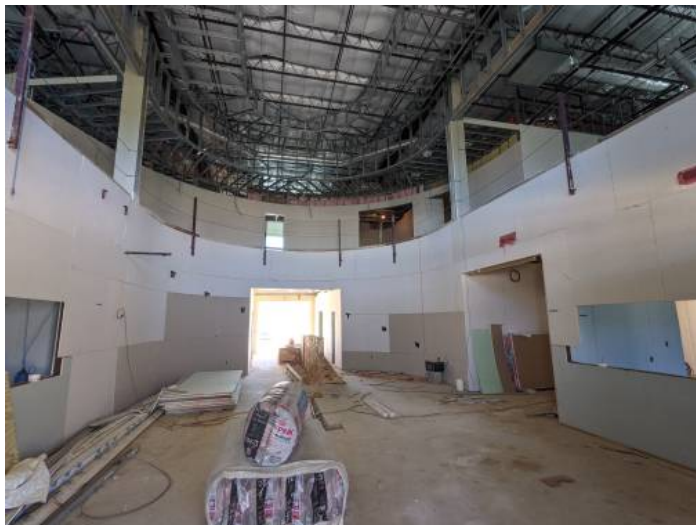
(3)

Lower elevation building. Wide view of the main entry.

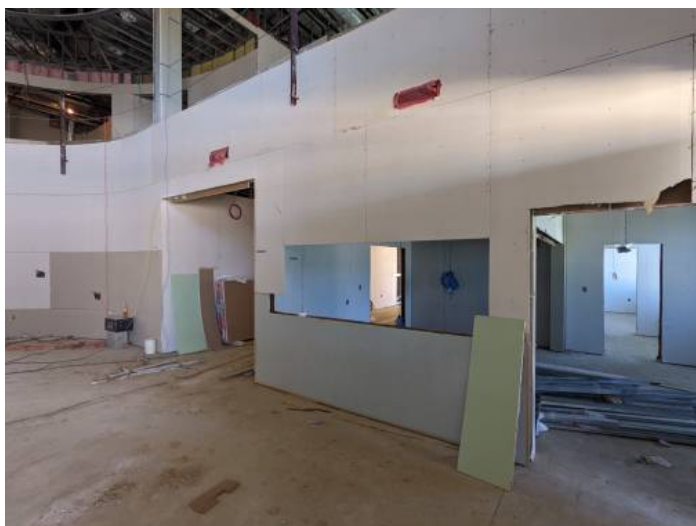
(4)

Lower elevation building. Wide view of the main entry. Water damage in this location was minimum overall.

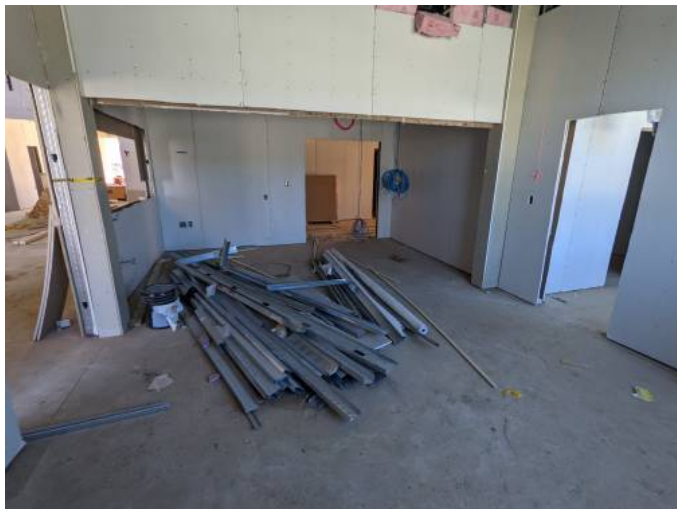
(5)

Lower elevation building. General or wide view of one of the rooms located to the right of the main entry.

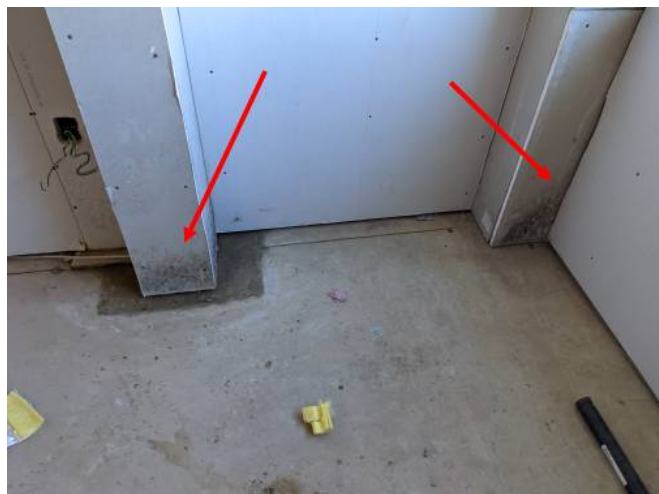
(7)

Lower elevation building. Close up view of one of the walls in the rooms located to the right of the main entry. Note there is visual mold growth along the base of the wall along the front elevation.

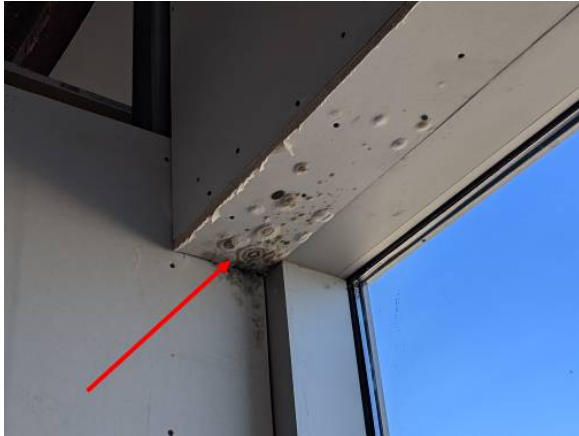
(9)

Lower elevation building. Close up view of one of the walls in the rooms located to the right of the main entry. Note there is visual mold growth located on the upper window frame return finish drywall. This is indicative of a leak associated with the building envelope or window above the window location.

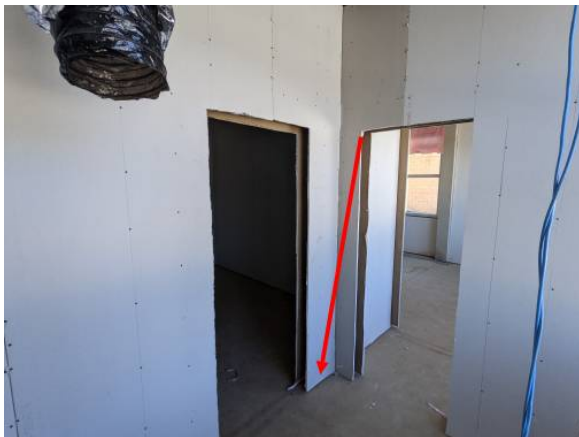
(10)

Lower elevation building. Close up view of one of the walls in the rooms located to the right of the main entry. As a general rule of thumb most of the drywall wall material hung is hung above the concrete floor surface. This minimizes the overall amount of damage to the drywall the interior portions of the property. However the significance of the water intrusion consisting of category 2 water contamination has negatively compromised the drywall material along the lower elevation building.

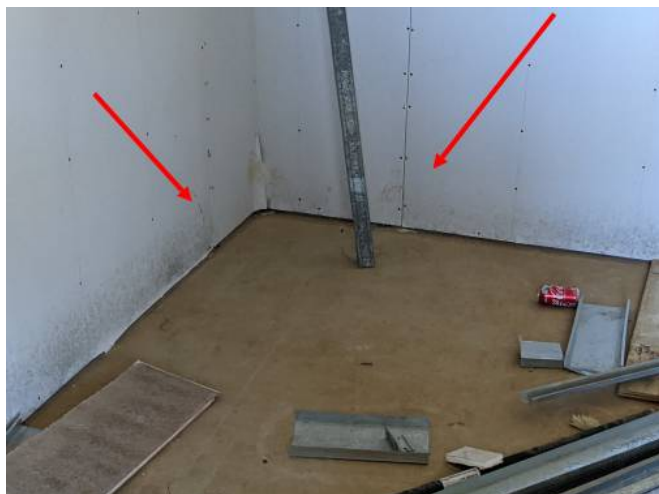
(11)

Lower elevation building. Close up view of one of the walls in the rooms located to the right of the main entry. Note there is visual mold growth along the base of the wall, which was a typical observation.

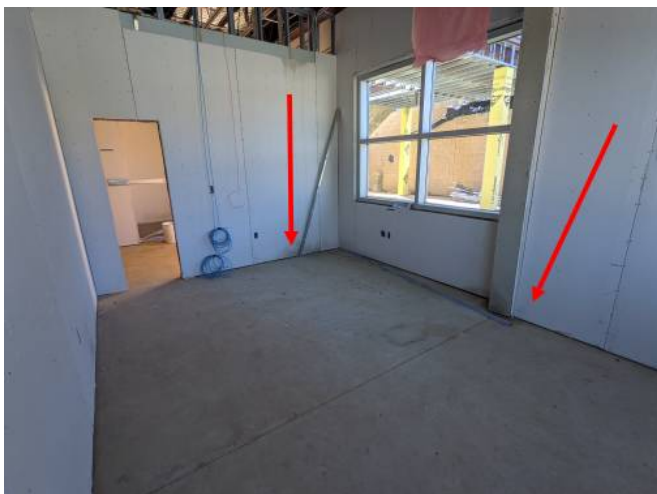
(13)

Lower elevation building. Close up view of one of the walls in the rooms located to the right of the main entry. Note there is visual mold growth along the base of the wall, which was a typical observation.

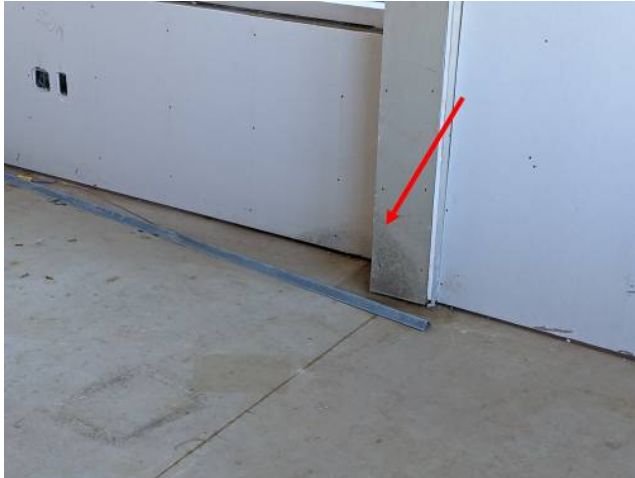
(15)

Lower elevation building. Close up view of one of the walls in the rooms located to the right of the main entry. Note there is visual mold growth along the base of the wall, which was a typical observation.

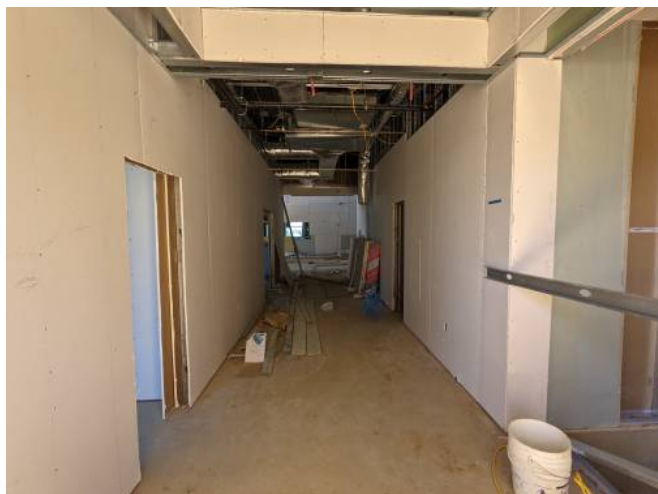
(17)

Lower elevation building. Wide view of a hallway leading from the front elevation towards the rear. No significant water damage was identified along the primary interior of the building.

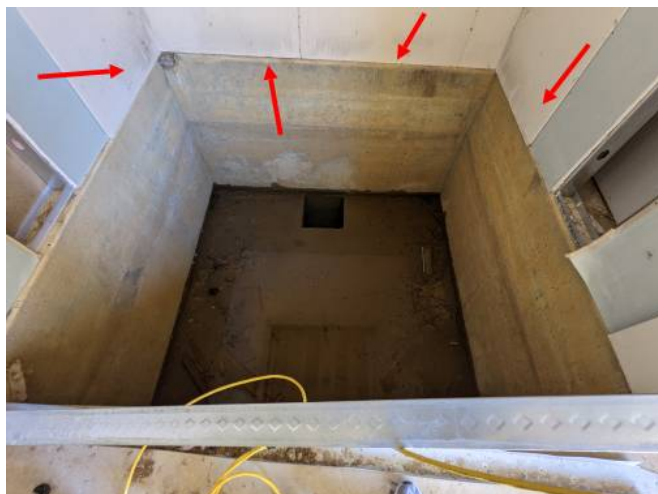
(19)

Lower elevation building. Wide view of the elevator shaft. There is ponding water in the bottom of the shaft and visual mold growth along the interior wall lining.

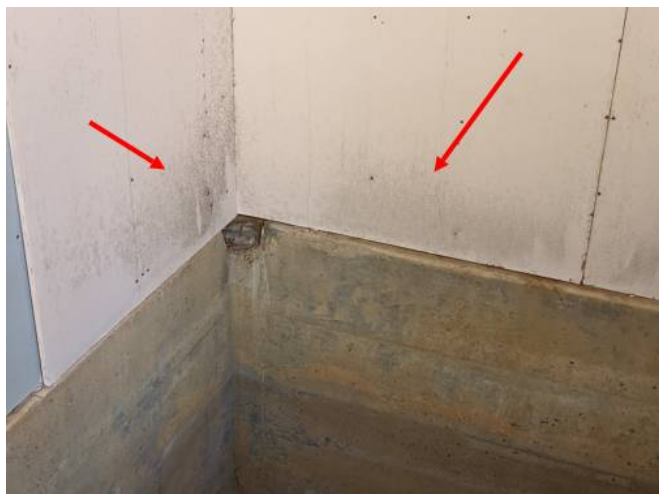
(21)

Lower elevation building. Close up view of the elevator shaft. There is ponding water in the bottom of the shaft and visual mold growth along the interior wall lining.

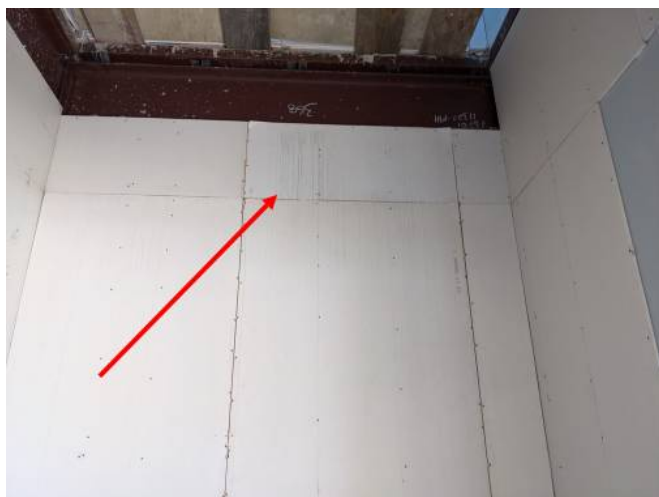
(22)

Lower elevation building. Wide view of the elevator shaft. There is water damage and visual mold growth along the interior wall lining near the top of the wall.

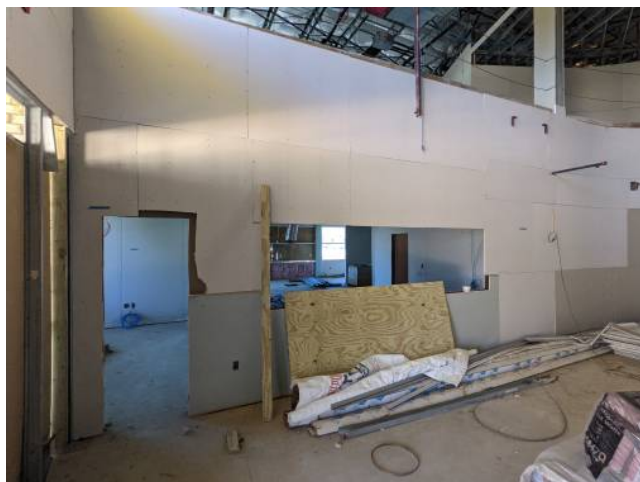
(23)

Lower elevation building. Wide view of the main entry looking towards the left. Again, the majority of the water damage is along the front and the base of the walls along the lower 2 ft to 4 ft.

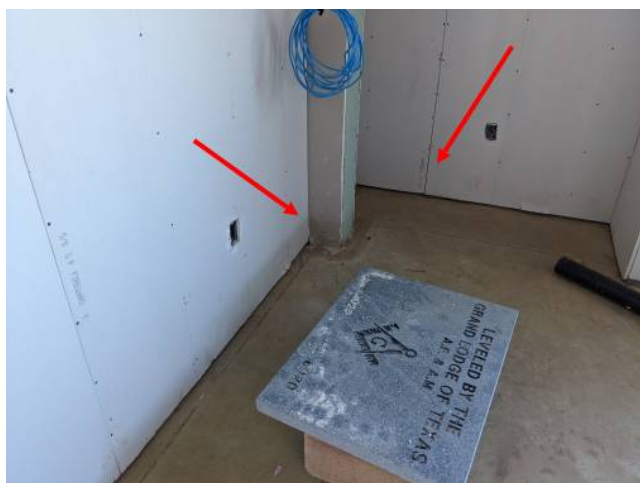
(24)

Lower elevation building. View of the spaces located to the left of the entry along the front and left side elevations. Again, the majority of the water damage is along the front and the base of the walls along the lower 2 ft to 4 ft.

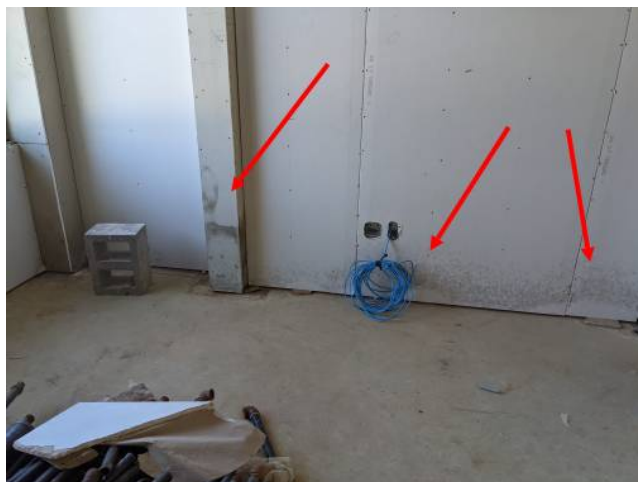
(25)

Lower elevation building. View of the spaces located to the left of the entry along the front and left side elevations. Again, the majority of the water damage is along the front and the base of the walls along the lower 2 ft to 4 ft.

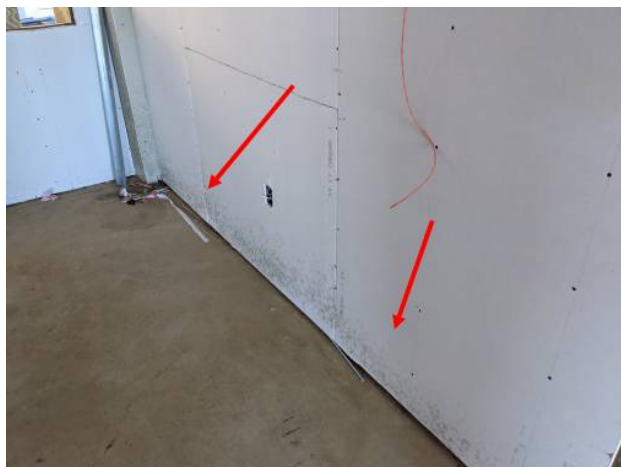
(27)

Lower elevation building. View of the spaces located to the left of the entry along the front and left side elevations. Again, the majority of the water damage is along the front and the base of the walls along the lower 2 ft to 4 ft.

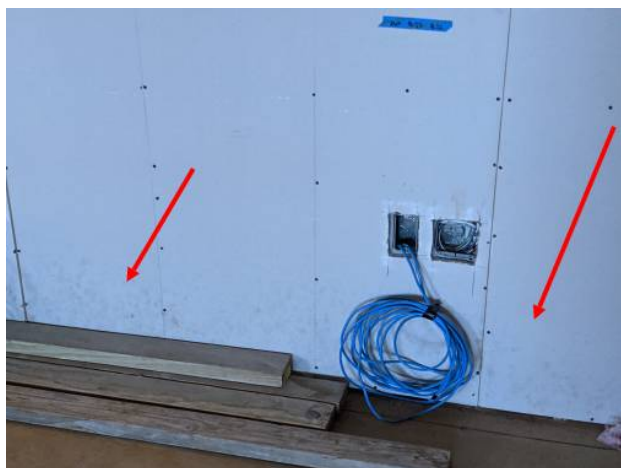
(28)

Lower elevation building. View of the spaces located to the left of the entry along the front and left side elevations. Again, the majority of the water damage is along the front and the base of the walls along the lower 2 ft to 4 ft.

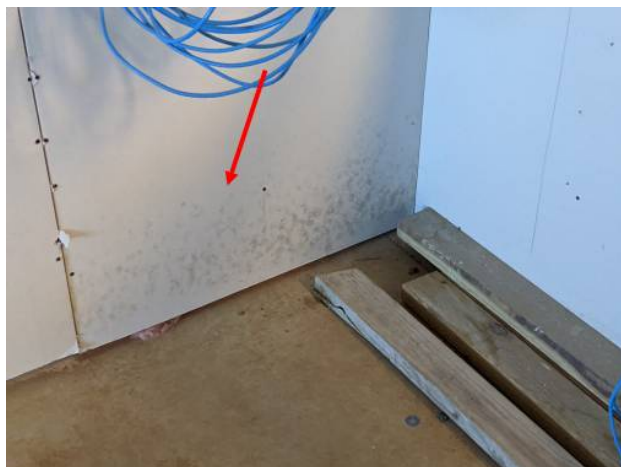
(29)

Lower elevation building. View of the spaces located to the left of the entry along the front and left side elevations. Again, the majority of the water damage is along the front and the base of the walls along the lower 2 ft to 4 ft.

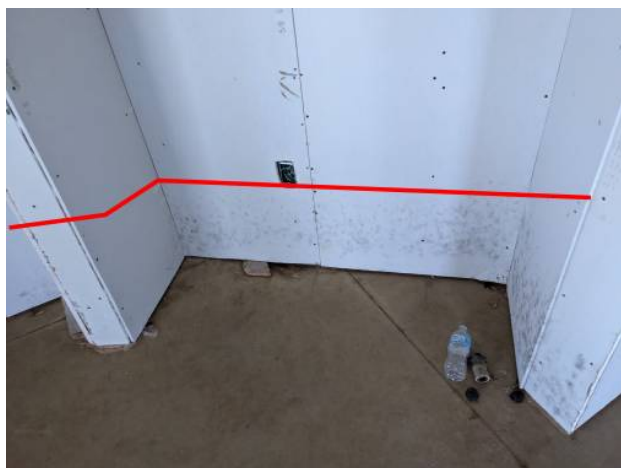
(30)

Lower elevation building. View of the spaces located to the left of the entry along the front and left side elevations. Again, the majority of the water damage is along the front and the base of the walls along the lower 2 ft to 4 ft.

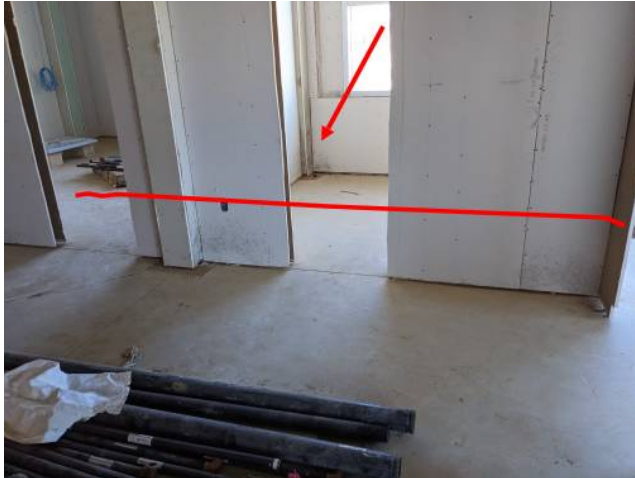
(31)

Lower elevation building. View of the spaces located to the left of the entry along the front and left side elevations. Again, the majority of the water damage is along the front and the base of the walls along the lower 2 ft to 4 ft.

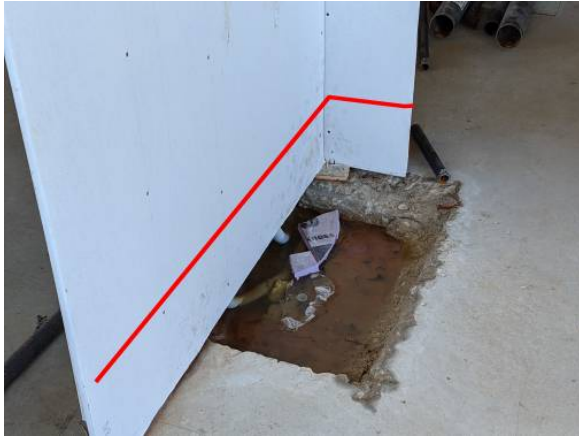
(33)

Lower elevation building. View of the spaces located to the left of the entry along the front and left side elevations. Again, the majority of the water damage is along the front and the base of the walls along the lower 2 ft to 4 ft. View of ponded water in a plumbing hole in the slab. This was a common observation throughout the main level.

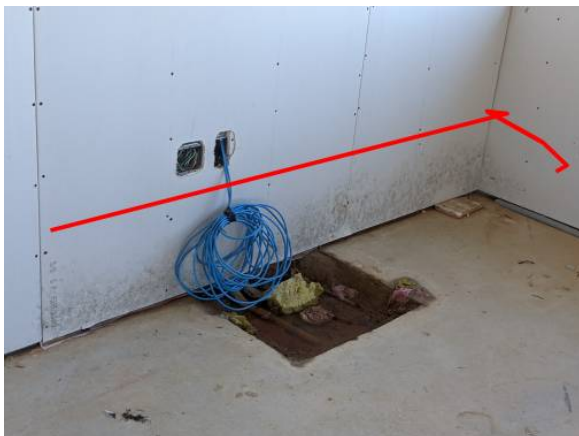
(34)

Lower elevation building. View of the spaces located to the left of the entry along the front and left side elevations. Again, the majority of the water damage is along the front and the base of the walls along the lower 2 ft to 4 ft. View of ponded water in a plumbing hole in the slab. This was a common observation throughout the main level.

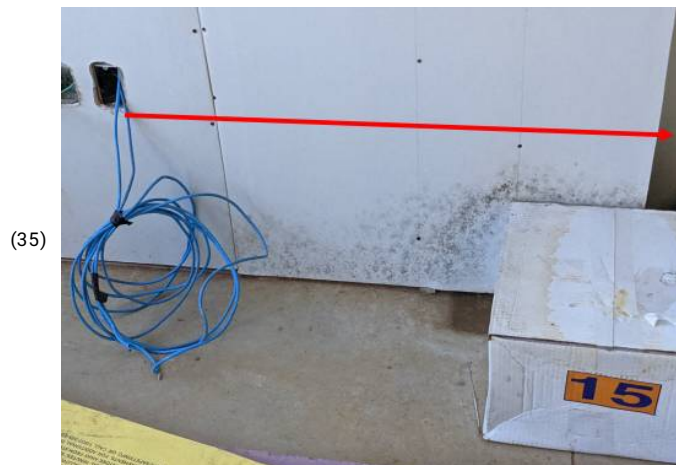
Lower elevation building. View of the spaces located to the left of the entry along the front and left side elevations. Again, the majority of the water damage is along the front and the base of the walls along the lower 2 ft to 4 ft.

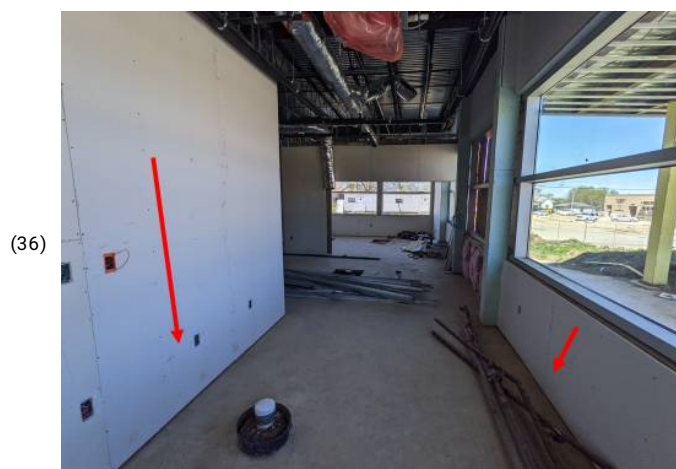
Lower elevation building. View of the spaces located to the left of the entry along the front and left side elevations. Again, the majority of the water damage is along the front and the base of the walls along the lower 2 ft to 4 ft.

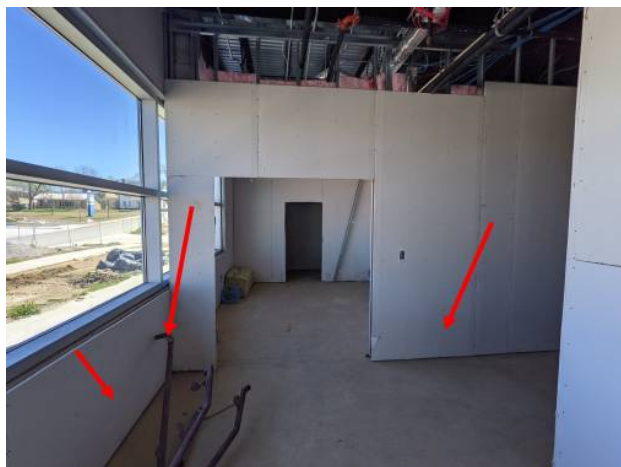
(37)

Lower elevation building. View of the spaces located to the left of the entry along the front and left side elevations. Again, the majority of the water damage is along the front and the base of the walls along the lower 2 ft to 4 ft.

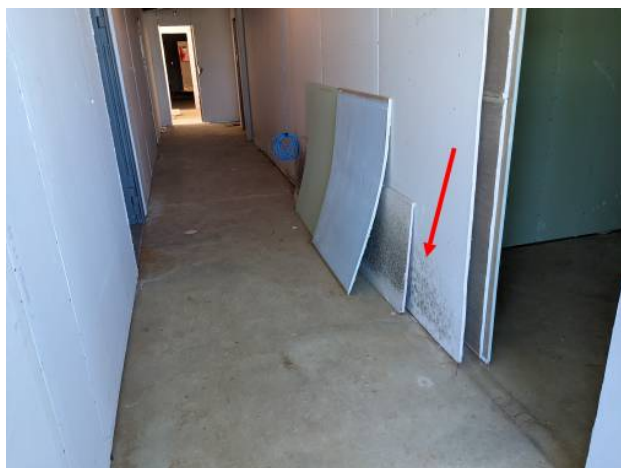
(38)

Lower elevation building. View of the spaces located to the left of the entry along the front and left side elevations. Again, the majority of the water damage is along the front and the base of the walls along the lower 2 ft to 4 ft.

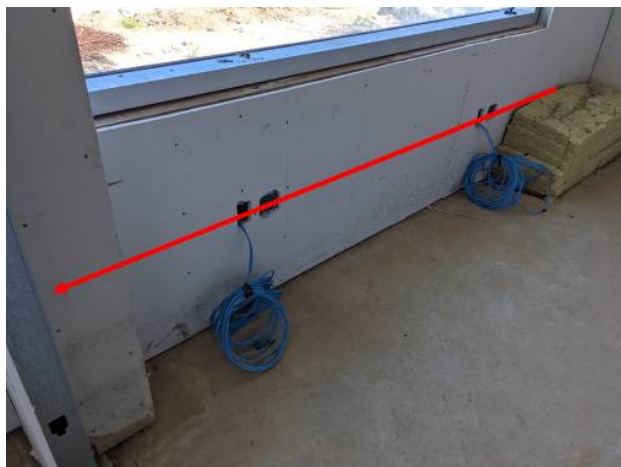
(39)

Lower elevation building. View of the spaces located to the left of the entry along the front and left side elevations. Again, the majority of the water damage is along the front and the base of the walls along the lower 2 ft to 4 ft.

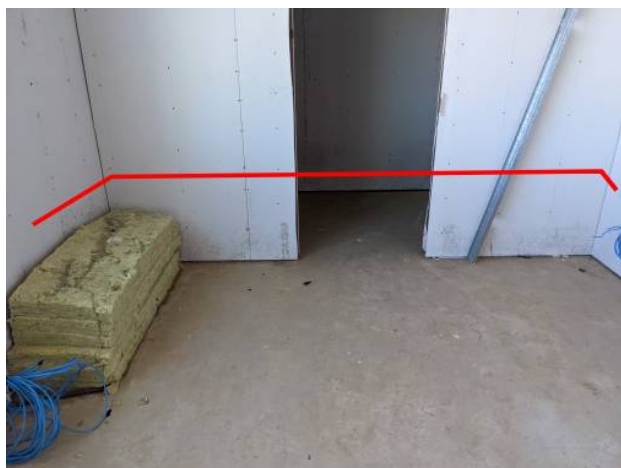
(40)

Lower elevation building. View of the spaces located to the left of the entry along the front and left side elevations. Again, the majority of the water damage is along the front and the base of the walls along the lower 2 ft to 4 ft.

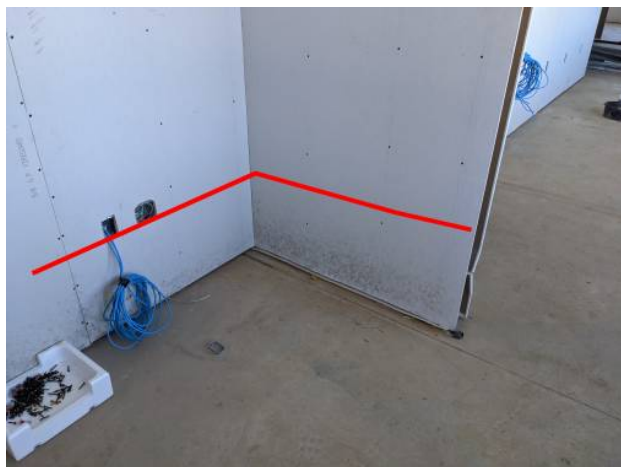
(41)

Lower elevation building. View of the spaces located to the left of the entry along the front and left side elevations. Again, the majority of the water damage is along the front and the base of the walls along the lower 2 ft to 4 ft.

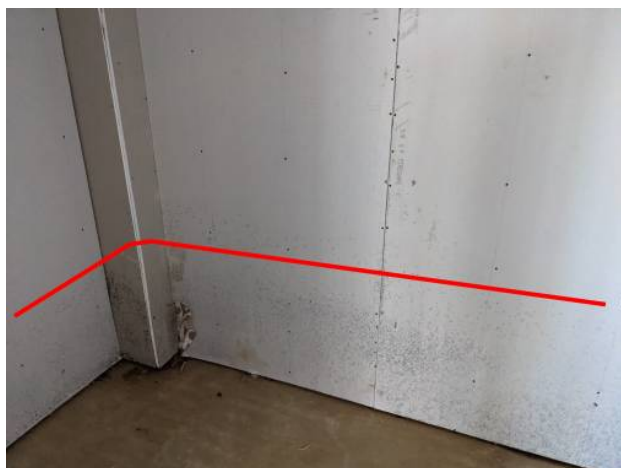
(42)

Lower elevation building. View of the spaces located to the left of the entry along the front and left side elevations. Again, the majority of the water damage is along the front and the base of the walls along the lower 2 ft to 4 ft.

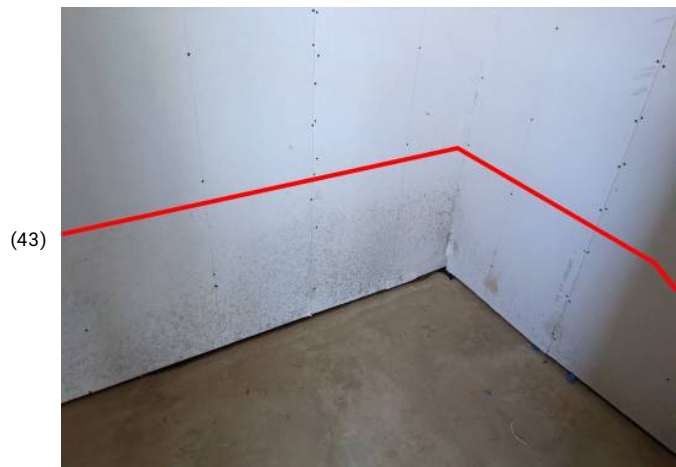
Lower elevation building. View of the spaces located to the left of the entry along the front and left side elevations. Again, the majority of the water damage is along the front and the base of the walls along the lower 2 ft to 4 ft.

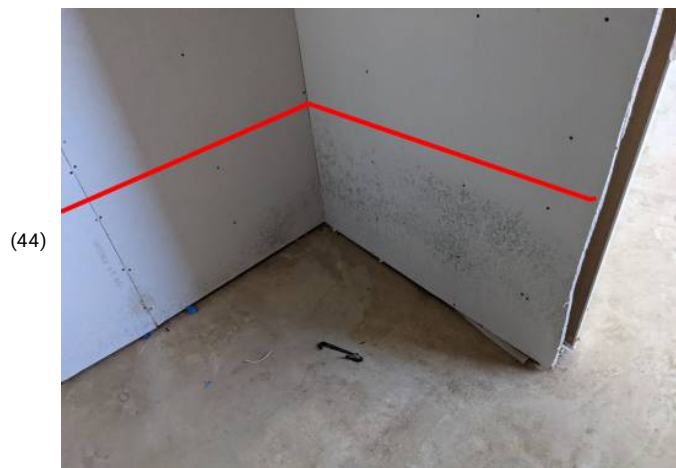
Lower elevation building. View of the spaces located to the left of the entry along the front and left side elevations. Again, the majority of the water damage is along the front and the base of the walls along the lower 2 ft to 4 ft.

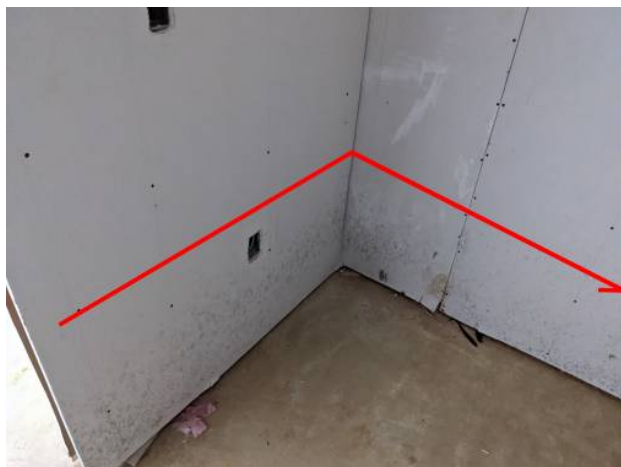
(45)

Lower elevation building. View of the spaces located to the left of the entry along the front and left side elevations. Again, the majority of the water damage is along the front and the base of the walls along the lower 2 ft to 4 ft.

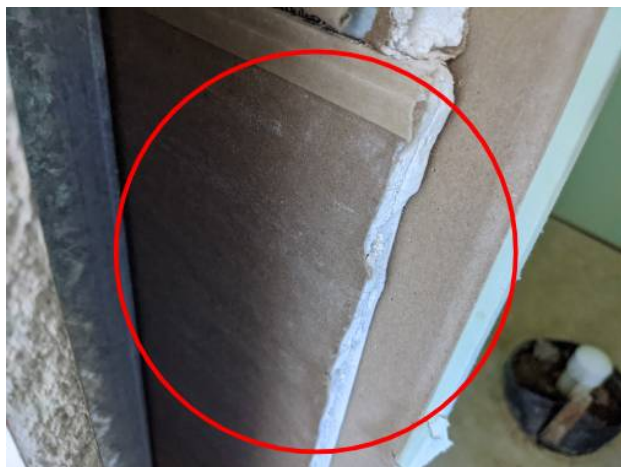
(47)

View of a section of the drywall installation on the main level where two layers are present. As seen in the photograph there is light visual surface mold growth on the inside surface of the wall cavity on each of the layers indicating the drywall material lack of climate control and drying.

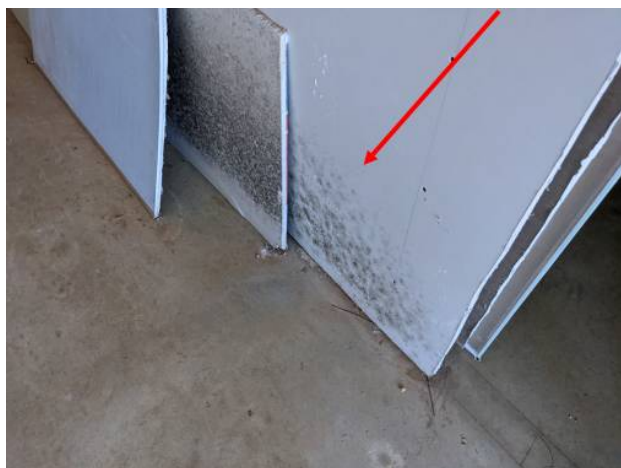
(48)

Lower elevation building. View of the spaces located to the left of the entry along the front and left side elevations. Again, the majority of the water damage is along the front and the base of the walls along the lower 2 ft to 4 ft.

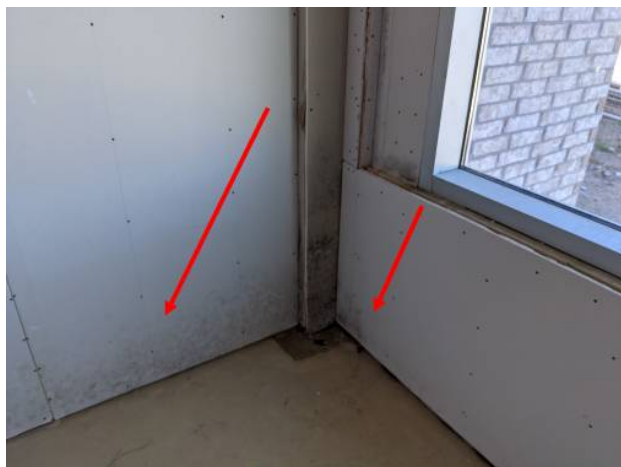
(51)

Lower elevation building. View of the spaces located to the left of the entry along the front and left side elevations. Again, the majority of the water damage is along the front and the base of the walls along the lower 2 ft to 4 ft.

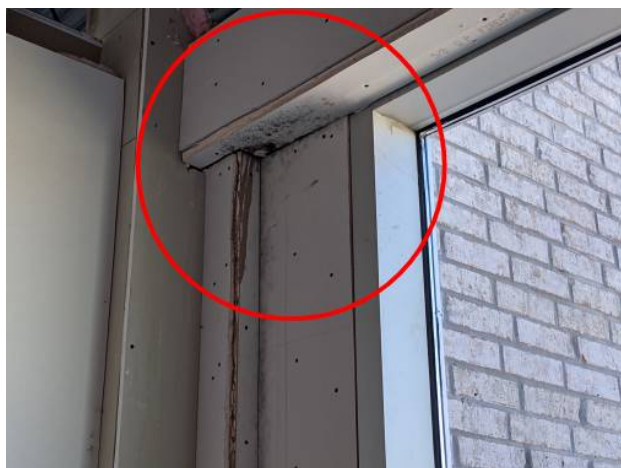
(52)

Lower elevation building. Close up view of one of the walls in the rooms located to the left of the main entry. Note there is visual mold growth located on the upper window frame return finish drywall. This is indicative of a leak associated with the building envelope or window above the window location.

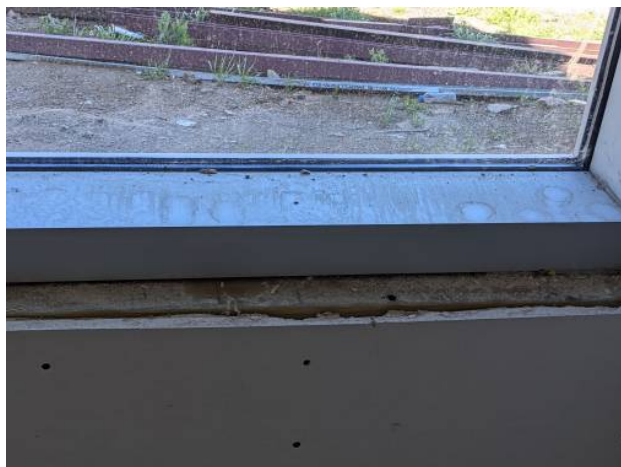
(53)

View of one of the window sill frame details along the far right elevation in the building located on the low end of the property. Water impaction marks appear to be due to dripping from the top down as a result of building envelope and or window failures.

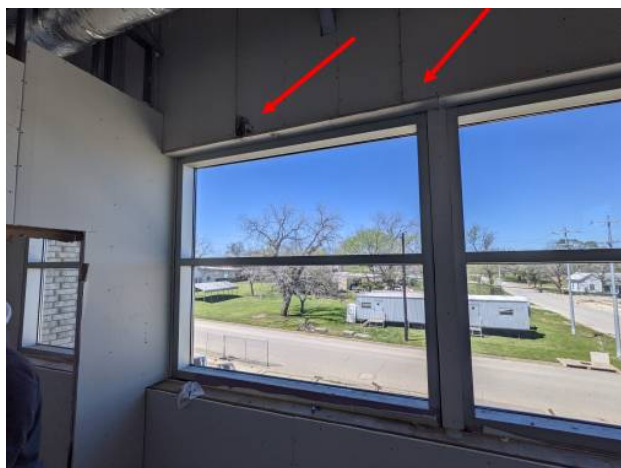
(54)

Wide view of leaking window detail on the lower building elevation section. Evidence of water intrusion in the form of staining, building wall material damage and visible mold growth are present along the exterior wall in this location.

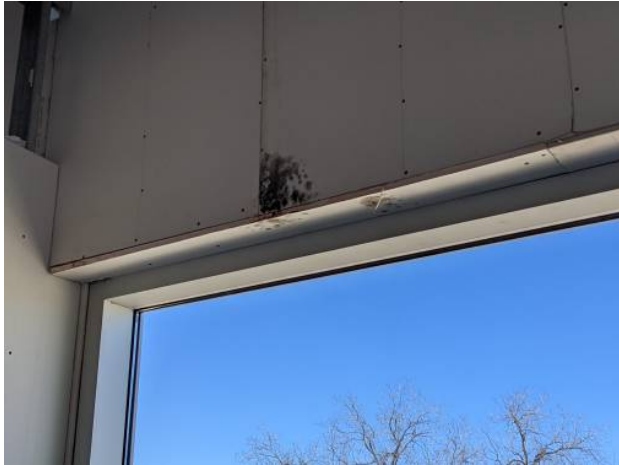
(55)

Close up view of leaking window detail on the lower building elevation section. Evidence of water intrusion in the form of staining, building wall material damage and visible mold growth are present along the exterior wall in this location.

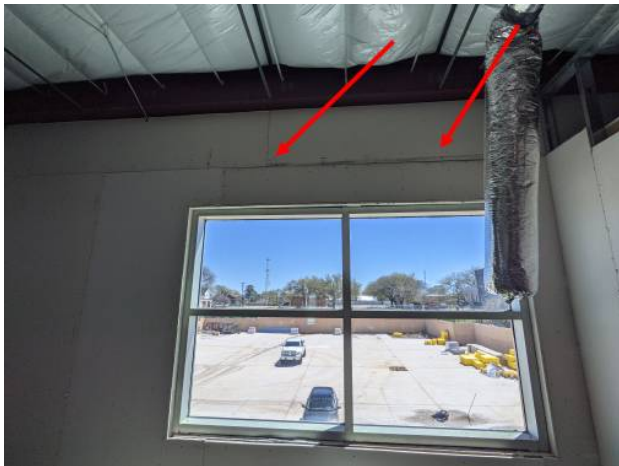
(56)

Wide view of leaking window detail on the lower building elevation section. Evidence of water intrusion in the form of staining, building wall material damage and visible mold growth are present along the exterior wall in this location.

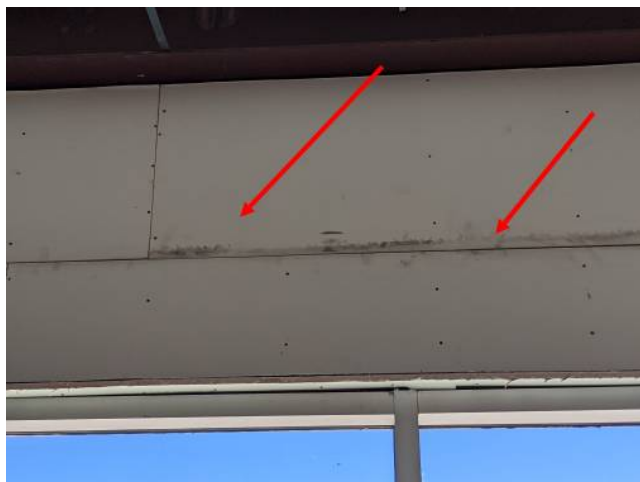
(57)

Wide view of leaking window detail on the lower building elevation section. Evidence of water intrusion in the form of staining, building wall material damage and visible mold growth are present along the exterior wall in this location.

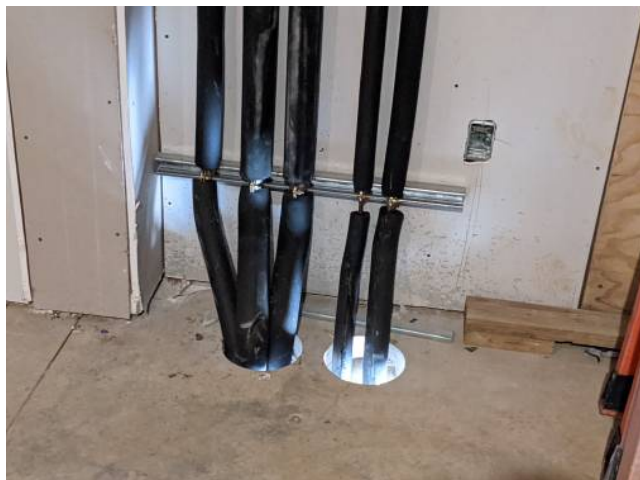
(58)

Evidence of non-weather-proof penetrations, which could allow water or unconditioned air to enter into the building. This could lead to ongoing and excessive water damage.

- Single-story and two-story buildings: Provide for building protection from the outdoor elements, which includes building envelope protection (exterior walls, windows and roof details), planned openings such as windows and doors as well as indoor environmental stabilization or conditioning to prevent secondary damage and condensation related contamination to non-water impacted building materials, finishes, insulation and mechanical equipment (HVAC, etc.). Monitoring and management of the interior conditions will be necessary until the building is protected by the outdoor elements, the ventilation system is working properly and substantial completion of the building is achieved.

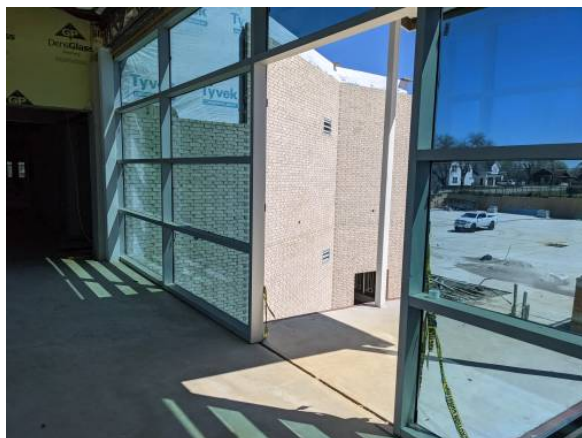
(59)

View of the upper level walkway leading from the building on the lower elevation of the property to the building located at a higher elevation on the property. This walkway has numerous openings and penetrations where direct water intrusion as well as unconditioned air can enter the building causing ongoing and severe water damage.

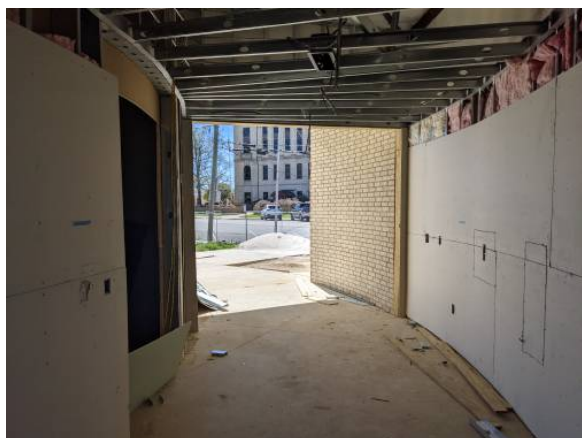
(60)

View of the upper level walkway leading from the building on the lower elevation of the property to the building located at a higher elevation on the property. This walkway has numerous openings and penetrations where direct water intrusion as well as unconditioned air can enter the building causing ongoing and severe water damage.

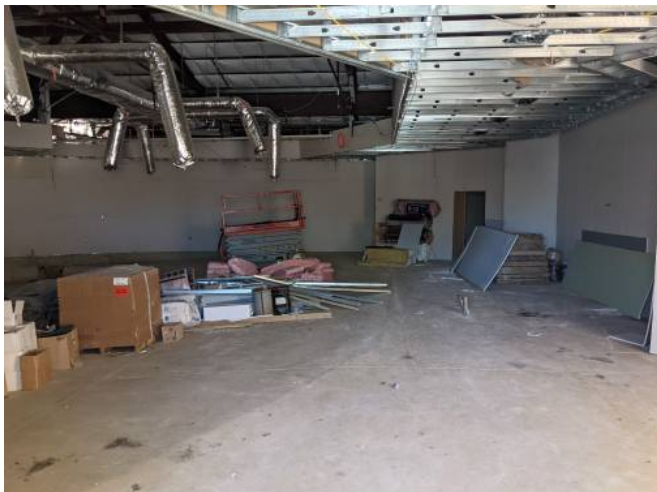
(61)

Wide view of the center area of the building located on the upper elevation. Note the ventilation system is not connected and this part of the building is exposed to the outdoor elements.

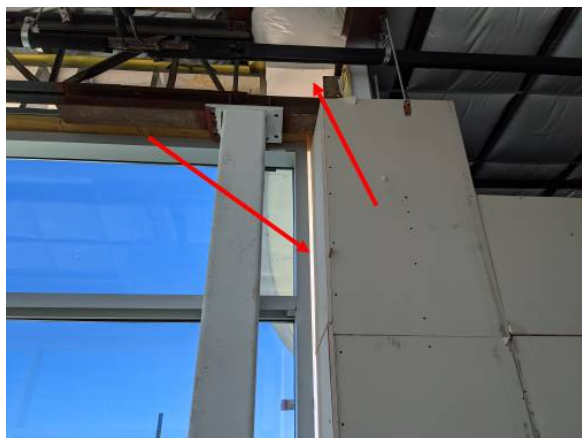
(63)

View of the upper level walkway leading from the building on the lower elevation of the property to the building located at a higher elevation on the property. This walkway has numerous openings and penetrations where direct water intrusion as well as unconditioned air can enter the building causing ongoing and severe water damage.

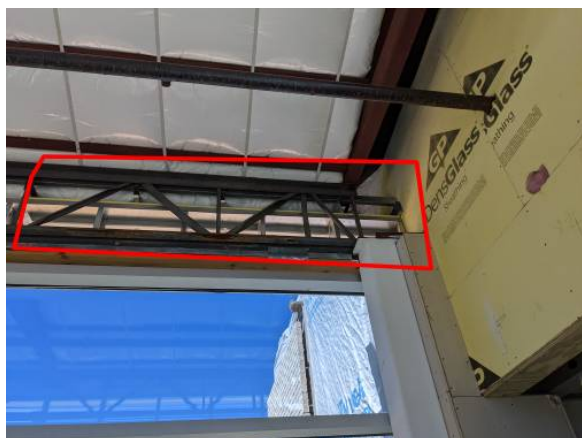
(64)

View of the upper level walkway leading from the building on the lower elevation of the property to the building located at a higher elevation on the property. This walkway has numerous openings and penetrations where direct water intrusion as well as unconditioned air can enter the building causing ongoing and severe water damage.

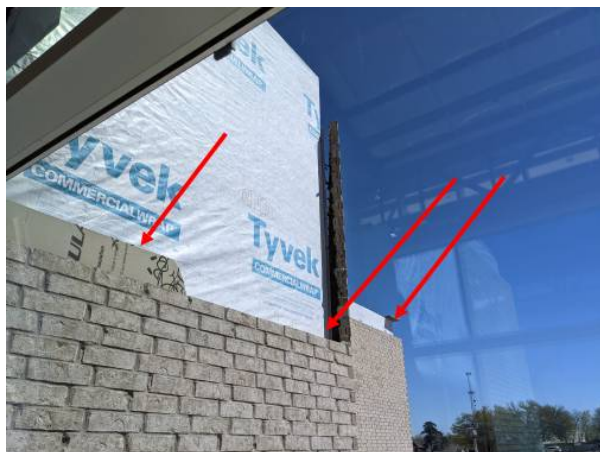
(65)

View of incomplete construction on the building exterior which can allow water intrusion behind the brick cladding water shedding system. This is going to cause ongoing water intrusion into the building, additional standing water and additional water damage and mold growth to the interior building materials.

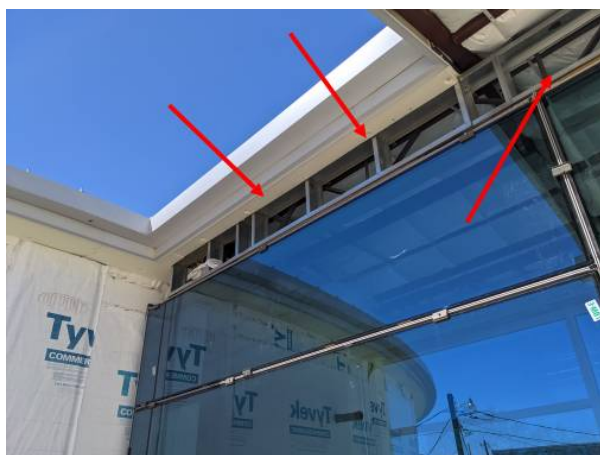
(66)

View of incomplete construction and multiple openings on the building exterior, which can allow water intrusion behind the brick cladding water shedding system. This is going to cause ongoing water intrusion into the building, additional standing water and additional water damage and mold growth to the interior building materials.

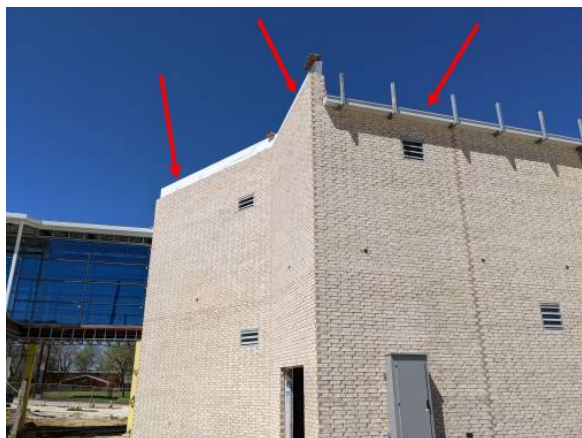
(67)

View of missing cap flashing details and general incomplete construction and multiple openings on the building exterior. This will allow water intrusion behind the brick cladding water shedding system. This is going to cause ongoing water intrusion into the building, additional standing water and additional water damage and mold growth to the interior building materials.

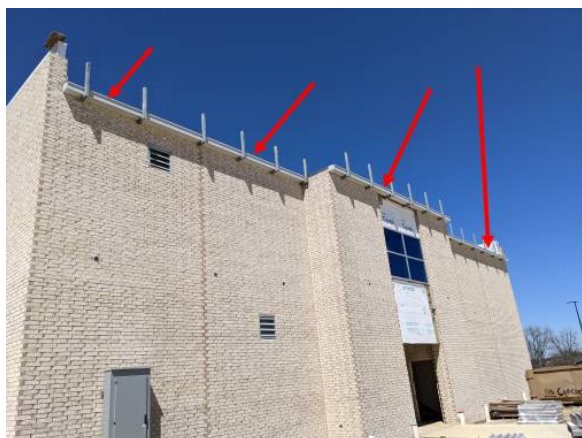
(68)

View of missing cap flashing details and general incomplete construction and multiple openings on the building exterior. This will allow water intrusion behind the brick cladding water shedding system. This is going to cause ongoing water intrusion into the building, additional standing water and additional water damage and mold growth to the interior building materials.
