# INVITATION FOR BID (IFB) PR157417-005034- Exhibit A

**Project Summary:** The Paducah Housing Authority has a duplex which sustained damage as a result of a fire. The purpose of the Invitation For Bid is for the specific work as indicated below. Purpose of the bid is complete smoke remediation and cleaning of affected surfaces. Work which is not included below is not to be included in this bid.

Created: Sat 25 Dec 19:39 2021 Location: Paducah Housing Authority - 2002 N. 7th Street, Paducah, TX Fire And Water Loss Assessment And Scope Title: No. Items: 41

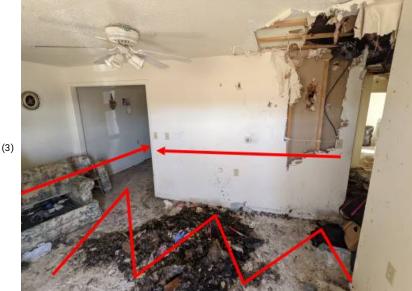
7190.jpeg

View of fire and water damaged interior as seen from the main entry. The areas outlined in red are recommended for removal. The lower two feet of wall materials along the left common wall between units and the lower 4 ft of all material common to the kitchen.

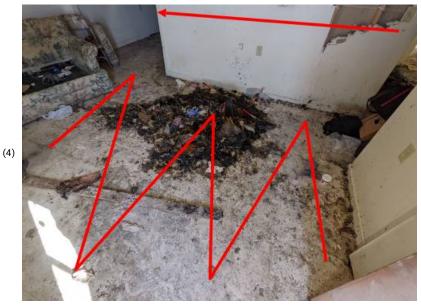
Additional view of water and fire particulate damage to the vinyl flooring in the living area. The vital flooring throughout the property should be removed.

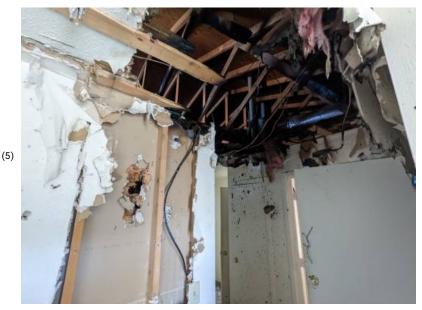
7192.jpeg

View of the hallway common between the front facing bedroom and kitchen. This is the general area where the source of the fire began in the attic space above the hallway. The ceiling and wall materials in this location should be removed from the primary affected area completely.

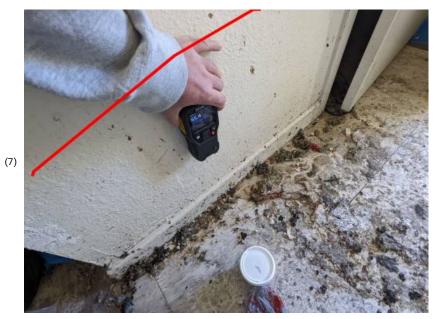
7194.jpeg

View of the moisture content reading along the lower 1 to 2 ft of the wall materials in the living room between the entry and common to the hallway closet.

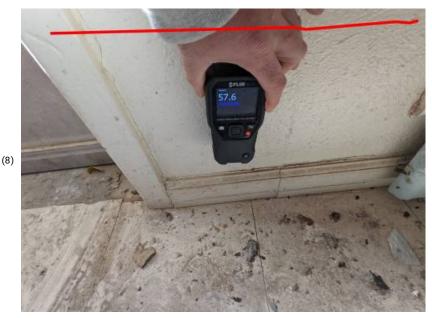
View of moisture content reading along the front facing elevation near the main entry. The lower 2 ft of wall material along the front facing elevation as well as common wall to the adjacent unit should be removed.

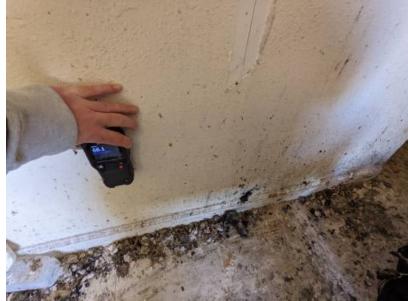
7196.jpeg

View of elevated moisture reading in the lower 1 to 2 ft of drywall wall material in the living room along the common wall between the adjacent unit. The lower 2 feet of wall material should be removed in this location.

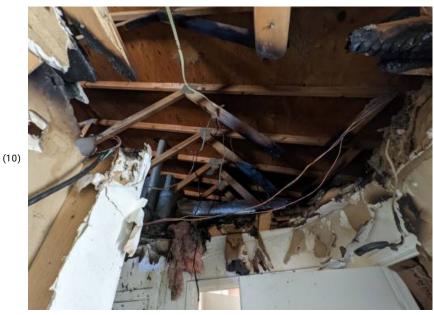
7197.jpeg

Additional view of the main hallway located to the right of the kitchen. Note this is where the source of fire originated in the attic space, which caused damage to the ceiling, walls and flooring materials below.

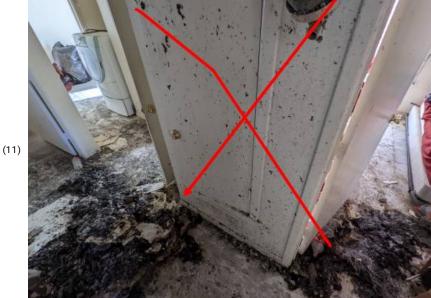
7198.jpeg

View of the main hallway under the source area or the fire occurred. The small closet in view in the hallway contains the HVAC system, which was impacted by the fire and water loss.

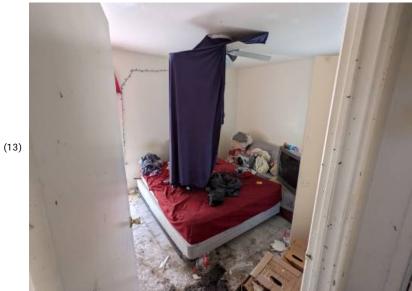
7200.jpeg

View of the front oriented bedroom located nearest the main entry. The fire and subsequent suppression water did enter this room and cause surface damage to much of the ceiling and wall materials as well as direct water impaction damage to the vinyl flooring and lower 2 ft of wall material.

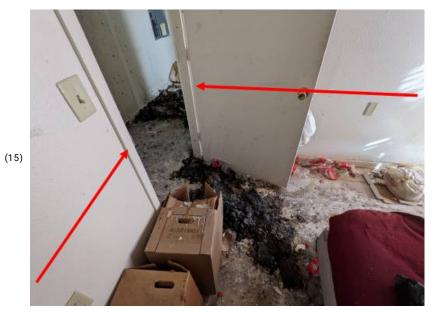
7202.jpeg

View of the front oriented bedroom located nearest the main entry. The fire and subsequent suppression water did enter this room and cause surface damage to much of the ceiling and wall materials as well as direct water impaction damage to the vinyl flooring and lower 2 ft of wall material.

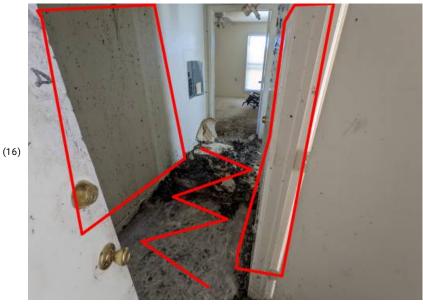
View of the main hallway below where the fire loss originated as seen from the front oriented bedroom. The wall materials, ceiling and flooring in the hallway were significantly fire / smoke and water damaged.

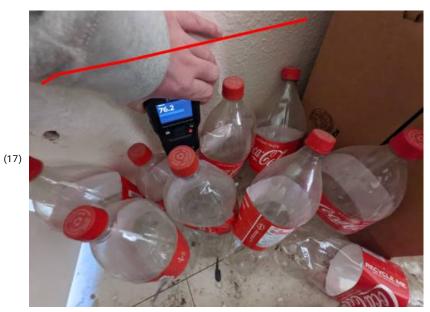
7204.jpeg

View of the front oriented bedroom located nearest the main entry. The fire and subsequent suppression water did enter this room and cause surface damage to much of the ceiling and wall materials as well as direct water impaction damage to the vinyl flooring and lower 2 ft of wall material.

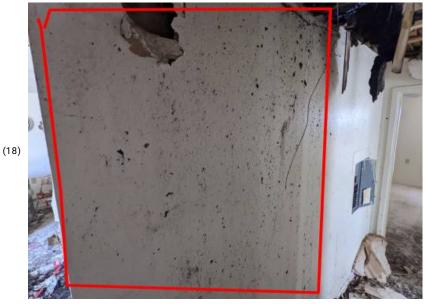
View of the primary hallway wall material common to the kitchen. This area was significantly water damaged and smoke damaged as a result of the fire.

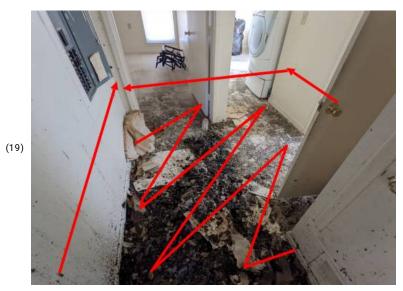
7206.jpeg

View of the main hallway flooring and wall materials as seen from the source area of the fire looking towards the rear of the property including the laundry room and a small room to the left of the laundry room. The primary materials of damage included the vinyl flooring and lower 2 ft of wall materials from this main hallway to the rear of the property.

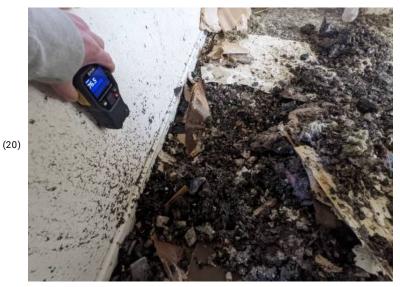
7207.jpeg

View of the main hallway flooring and wall materials as seen from the source area of the fire looking towards the rear of the property including the laundry room and a small room to the left of the laundry room. The primary materials of damage included the vinyl flooring and lower 2 ft of wall materials from this main hallway to the rear of the property.

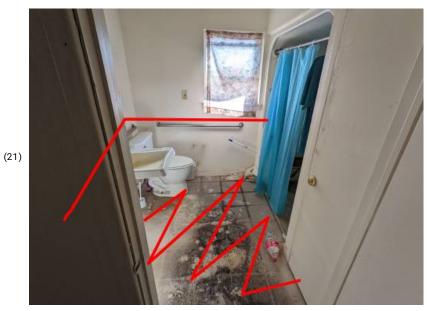
7208.jpeg

View of the hallway bathroom along the right side of the property. Suppression water entered the bathroom along the floor impacting and damaging the vinyl floor tile as well as the lower 2 ft of wall materials throughout.

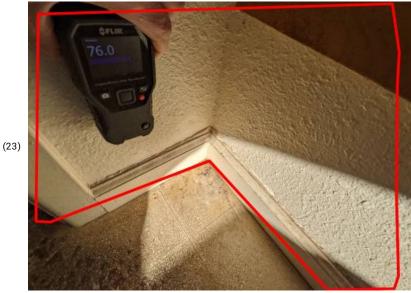
7210.jpeg

View of the hallway bathroom along the right side of the property. Suppression water entered the bathroom along the floor impacting and damaging the vinyl floor tile as well as the lower 2 ft of wall materials throughout.

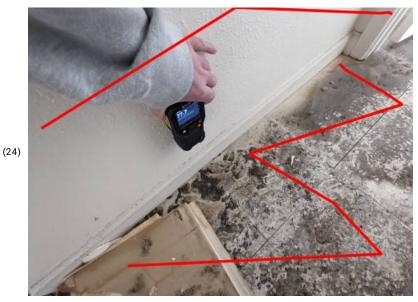
7211.jpeg

View of the elevated moisture content in the wall material in the laundry room area near the rear of the property. The lower 2 ft of wall material and vinyl flooring were primarily impacted outside of the direct fire loss area.

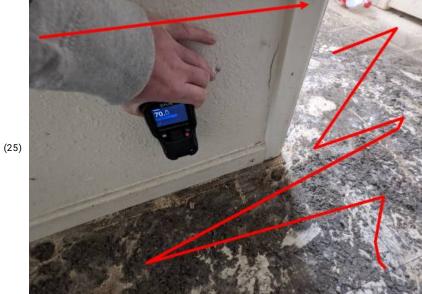
7212.jpeg

View of the elevated moisture content in the wall material in the hallway and laundry room area near the rear of the property. The lower 2 ft of wall material and vinyl flooring were primarily impacted outside of the direct fire loss area.

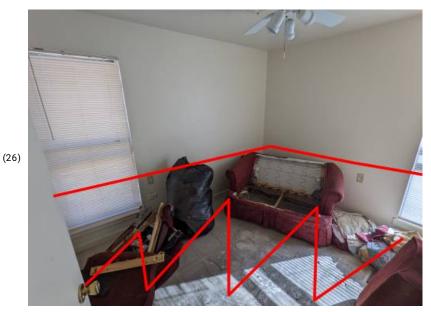
View of the rear bedroom in the property. The vinyl floor tile and lower 2 ft of wall material throughout this room were impacted and are recommended for removal.

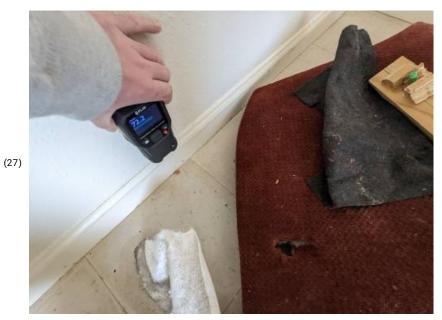
7214.jpeg

View of the rear bedroom in the property. The vinyl floor tile and lower 2 ft of wall material throughout this room were impacted and are recommended for removal.

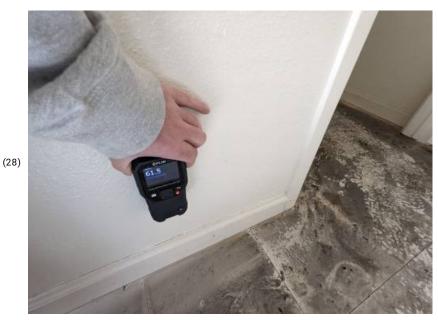
View of the rear bedroom in the property. The vinyl floor tile and lower 2 ft of wall material throughout this room were impacted and are recommended for removal.

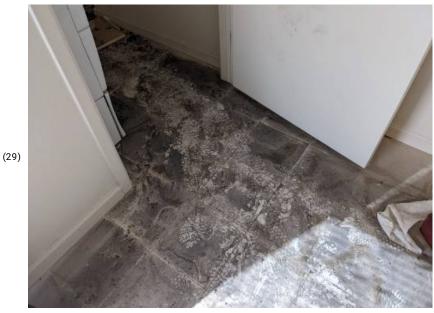
7216.jpeg

View of the rear bedroom in the property. The vinyl floor tile and lower 2 ft of wall material throughout this room were impacted and are recommended for removal.

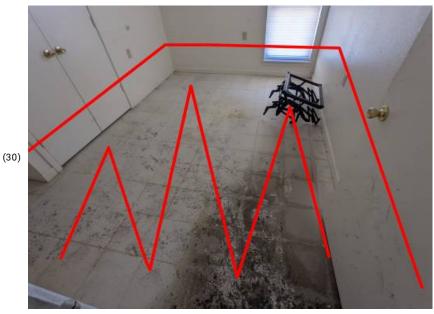
View of the rear utility room in the center, rear of the property. The vinyl floor tile and lower 2 ft of wall material throughout this room were impacted and are recommended for removal.

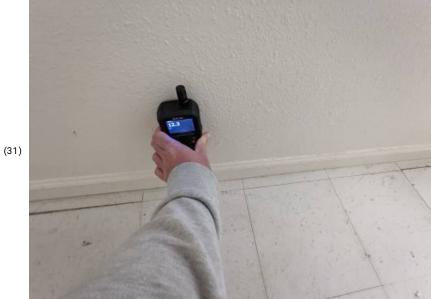
7218.jpeg

View of the rear utility room in the center, rear of the property. The vinyl floor tile and lower 2 ft of wall material throughout this room were impacted and are recommended for removal.

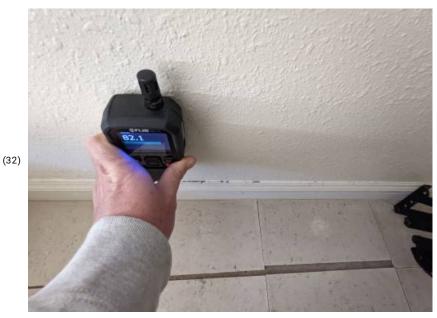
View of the rear utility room in the center, rear of the property. The vinyl floor tile and lower 2 ft of wall material throughout this room were impacted and are recommended for removal.

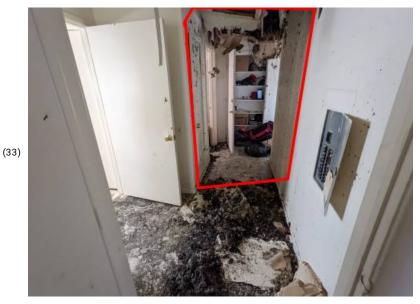
7220.jpeg

View of the main hallway as seen from the rear utility room back towards the kitchen and source of the fire loss in the hallway attic. The area outlined in red should be fully demoed or removed and all of the areas should have vinyl floor tile removed and lower 2 ft of wall materials removed.

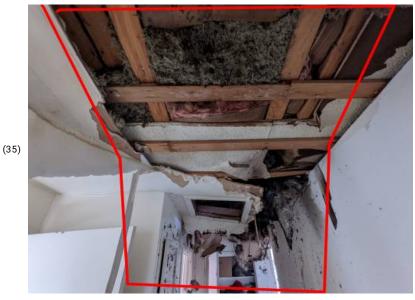
7222.jpeg

View of the main hallway as seen from the rear utility room back towards the kitchen and source of the fire loss in the hallway attic. The area outlined in red should be fully demoed or removed and all of the areas should have vinyl floor tile removed and lower 2 ft of wall materials removed.

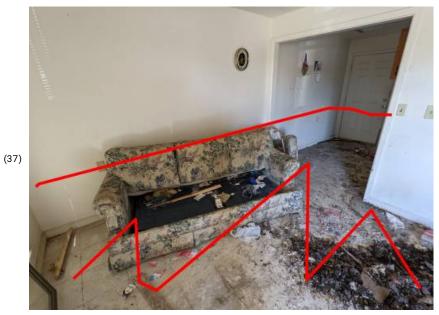
7224.jpeg

View of the main living room along the common wall to the adjacent unit. All of the vinyl floor tile and lower 2 ft of wall materials in view should be removed as part of the fire restoration project.
