TurnKey Recovery™
Managed Direct Repair Program

<u>IFB Number</u>	<u>Scope Description</u>	<u>Closing Date</u>	<u>Closing Time</u>
PR185762-028072-12201	Hangar Repairs (ID 072)	03/10/2023	4:30 PM CST

Bldg 210 - Hangars A, B and C:

Re: City Owned Hangars
Wind Damage
210 - 212 and 216 - 218 E. Airline Ave.
Eagle Lake, TX

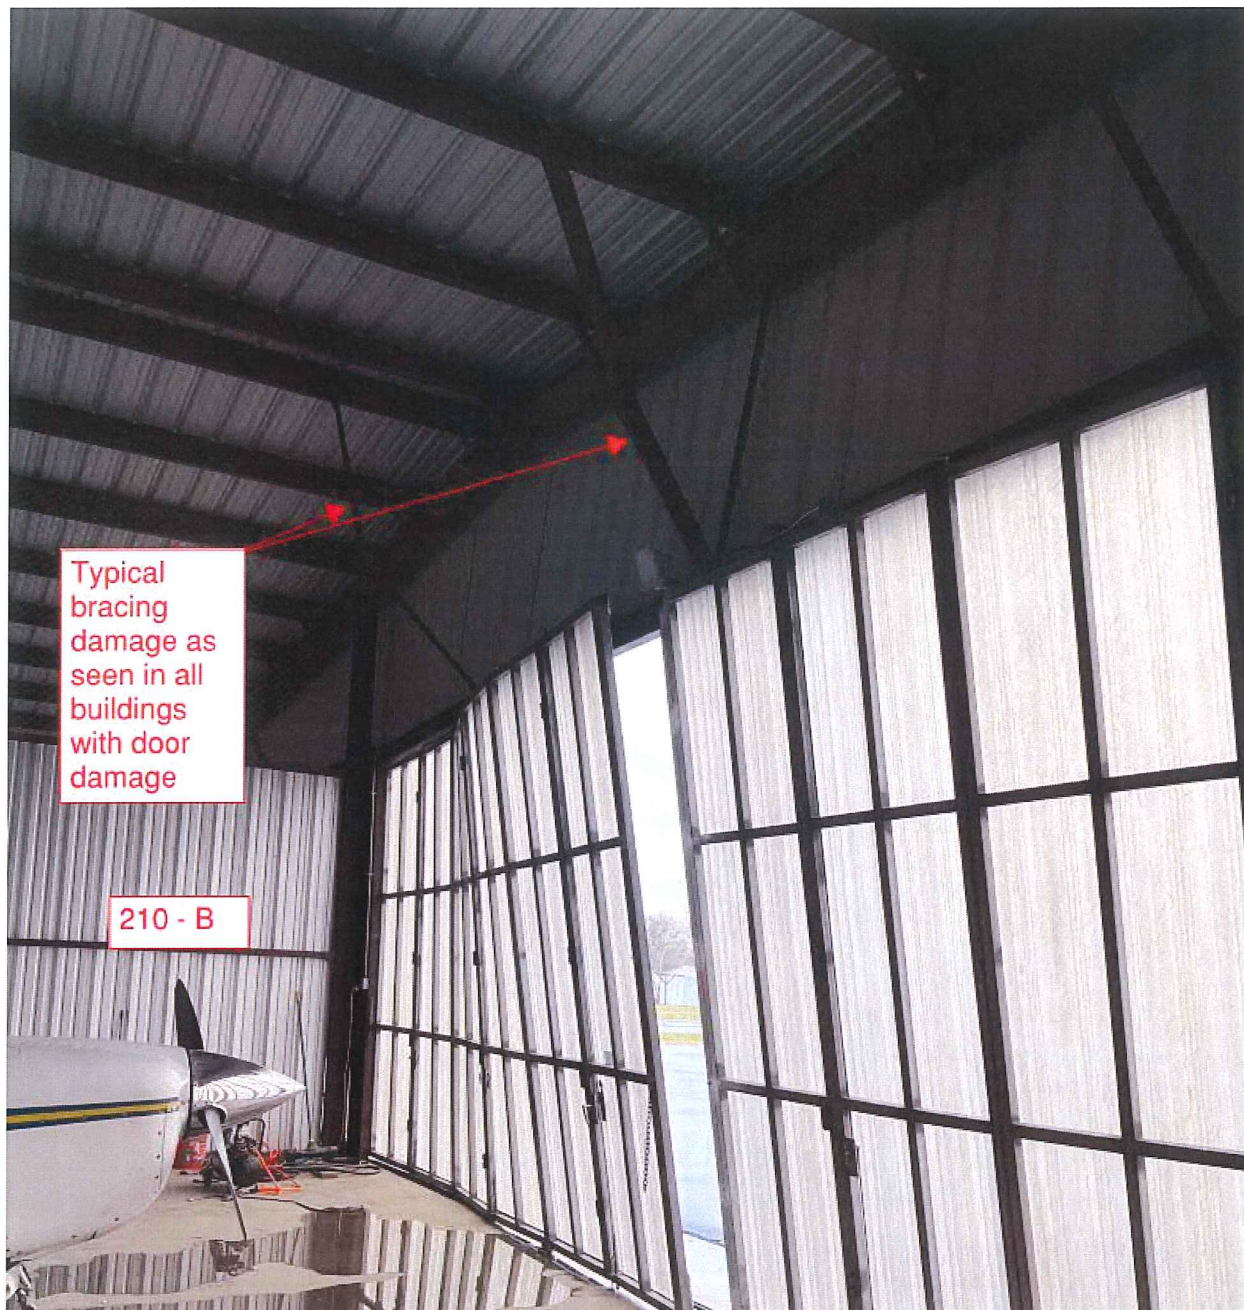
210 - B

Typical
bracing
damage as
seen in all
buildings
with door
damage

Buildings 210 and 216, hangars A, B, and C will need to have their door frames, door headers and header braces replaced. Also, the door frame to the building column brackets will need replacing. Building 216 has several damaged roof purlins that will need replacing as well.

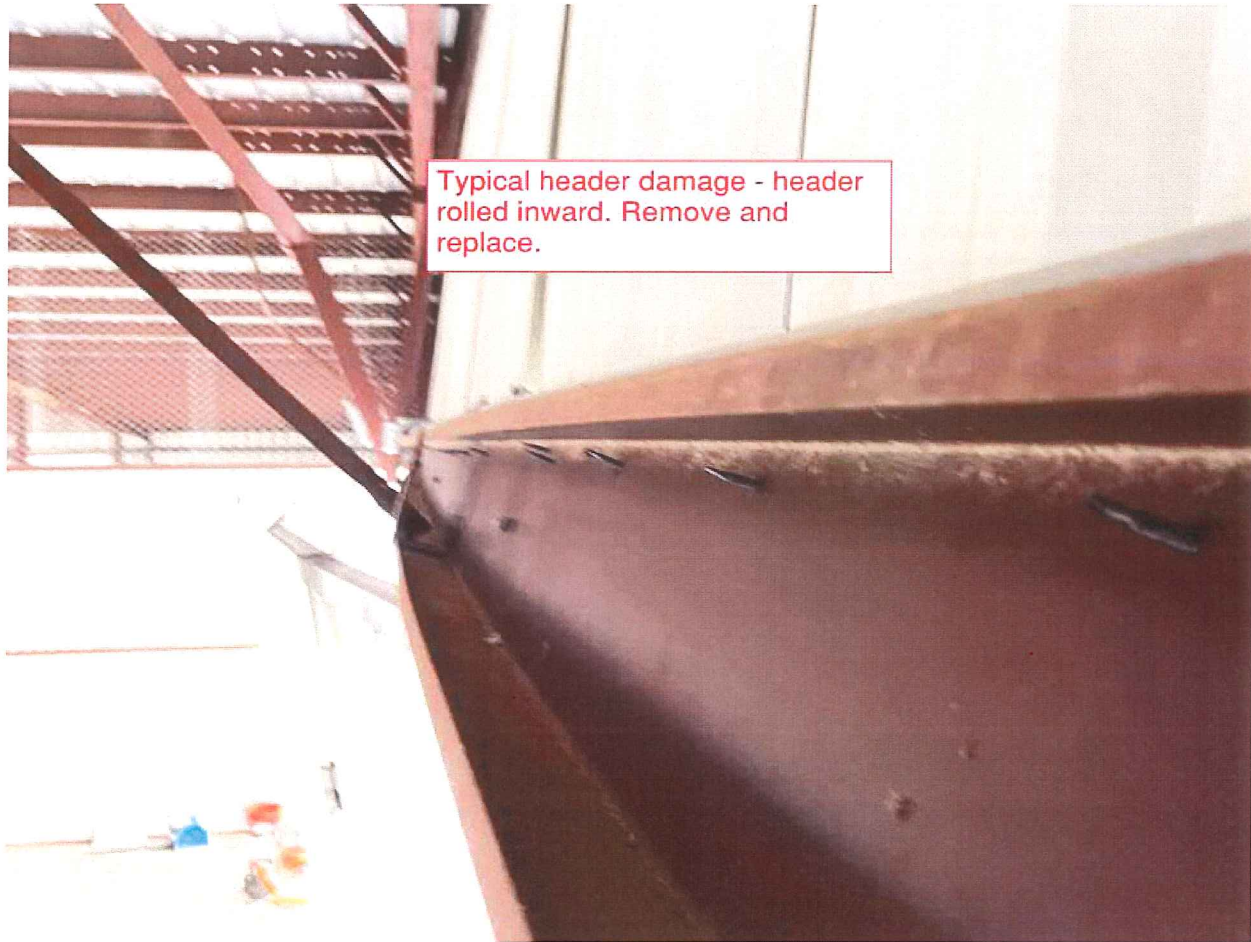
Typical header damage - header rolled inward. Remove and replace.

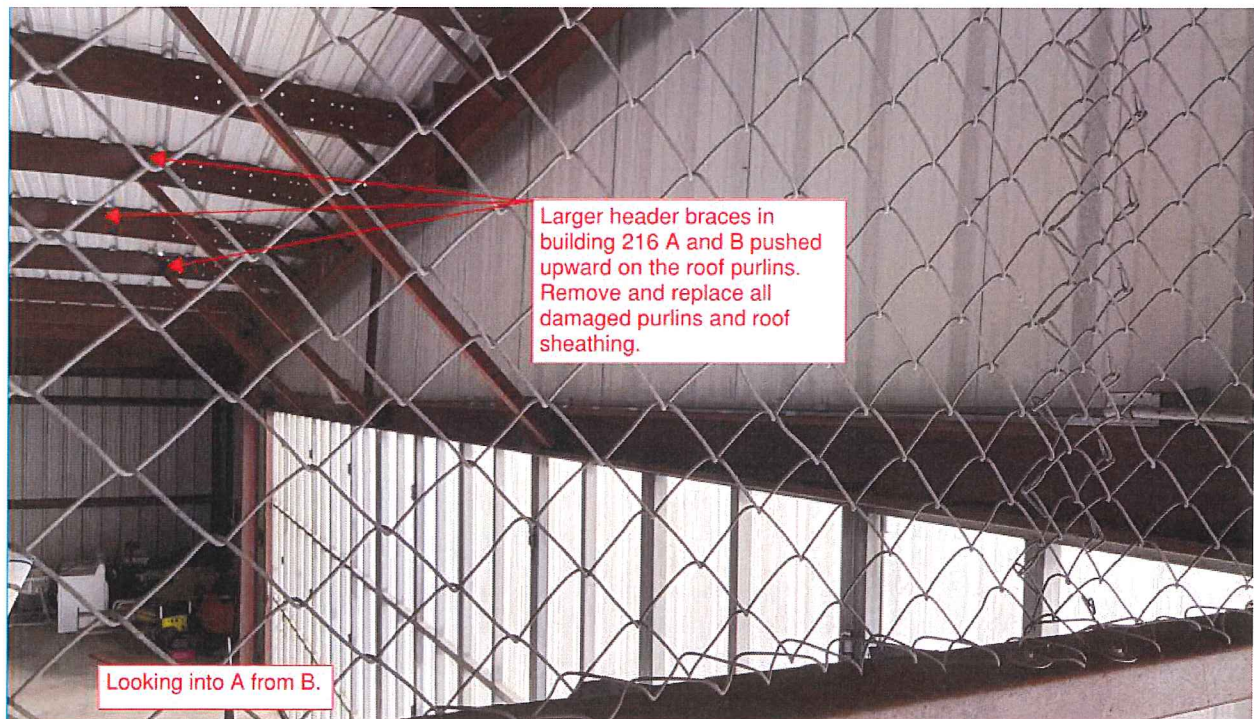
Looking into A from B.

Larger header braces in building 216 A and B pushed upward on the roof purlins. Remove and replace all damaged purlins and roof sheathing.

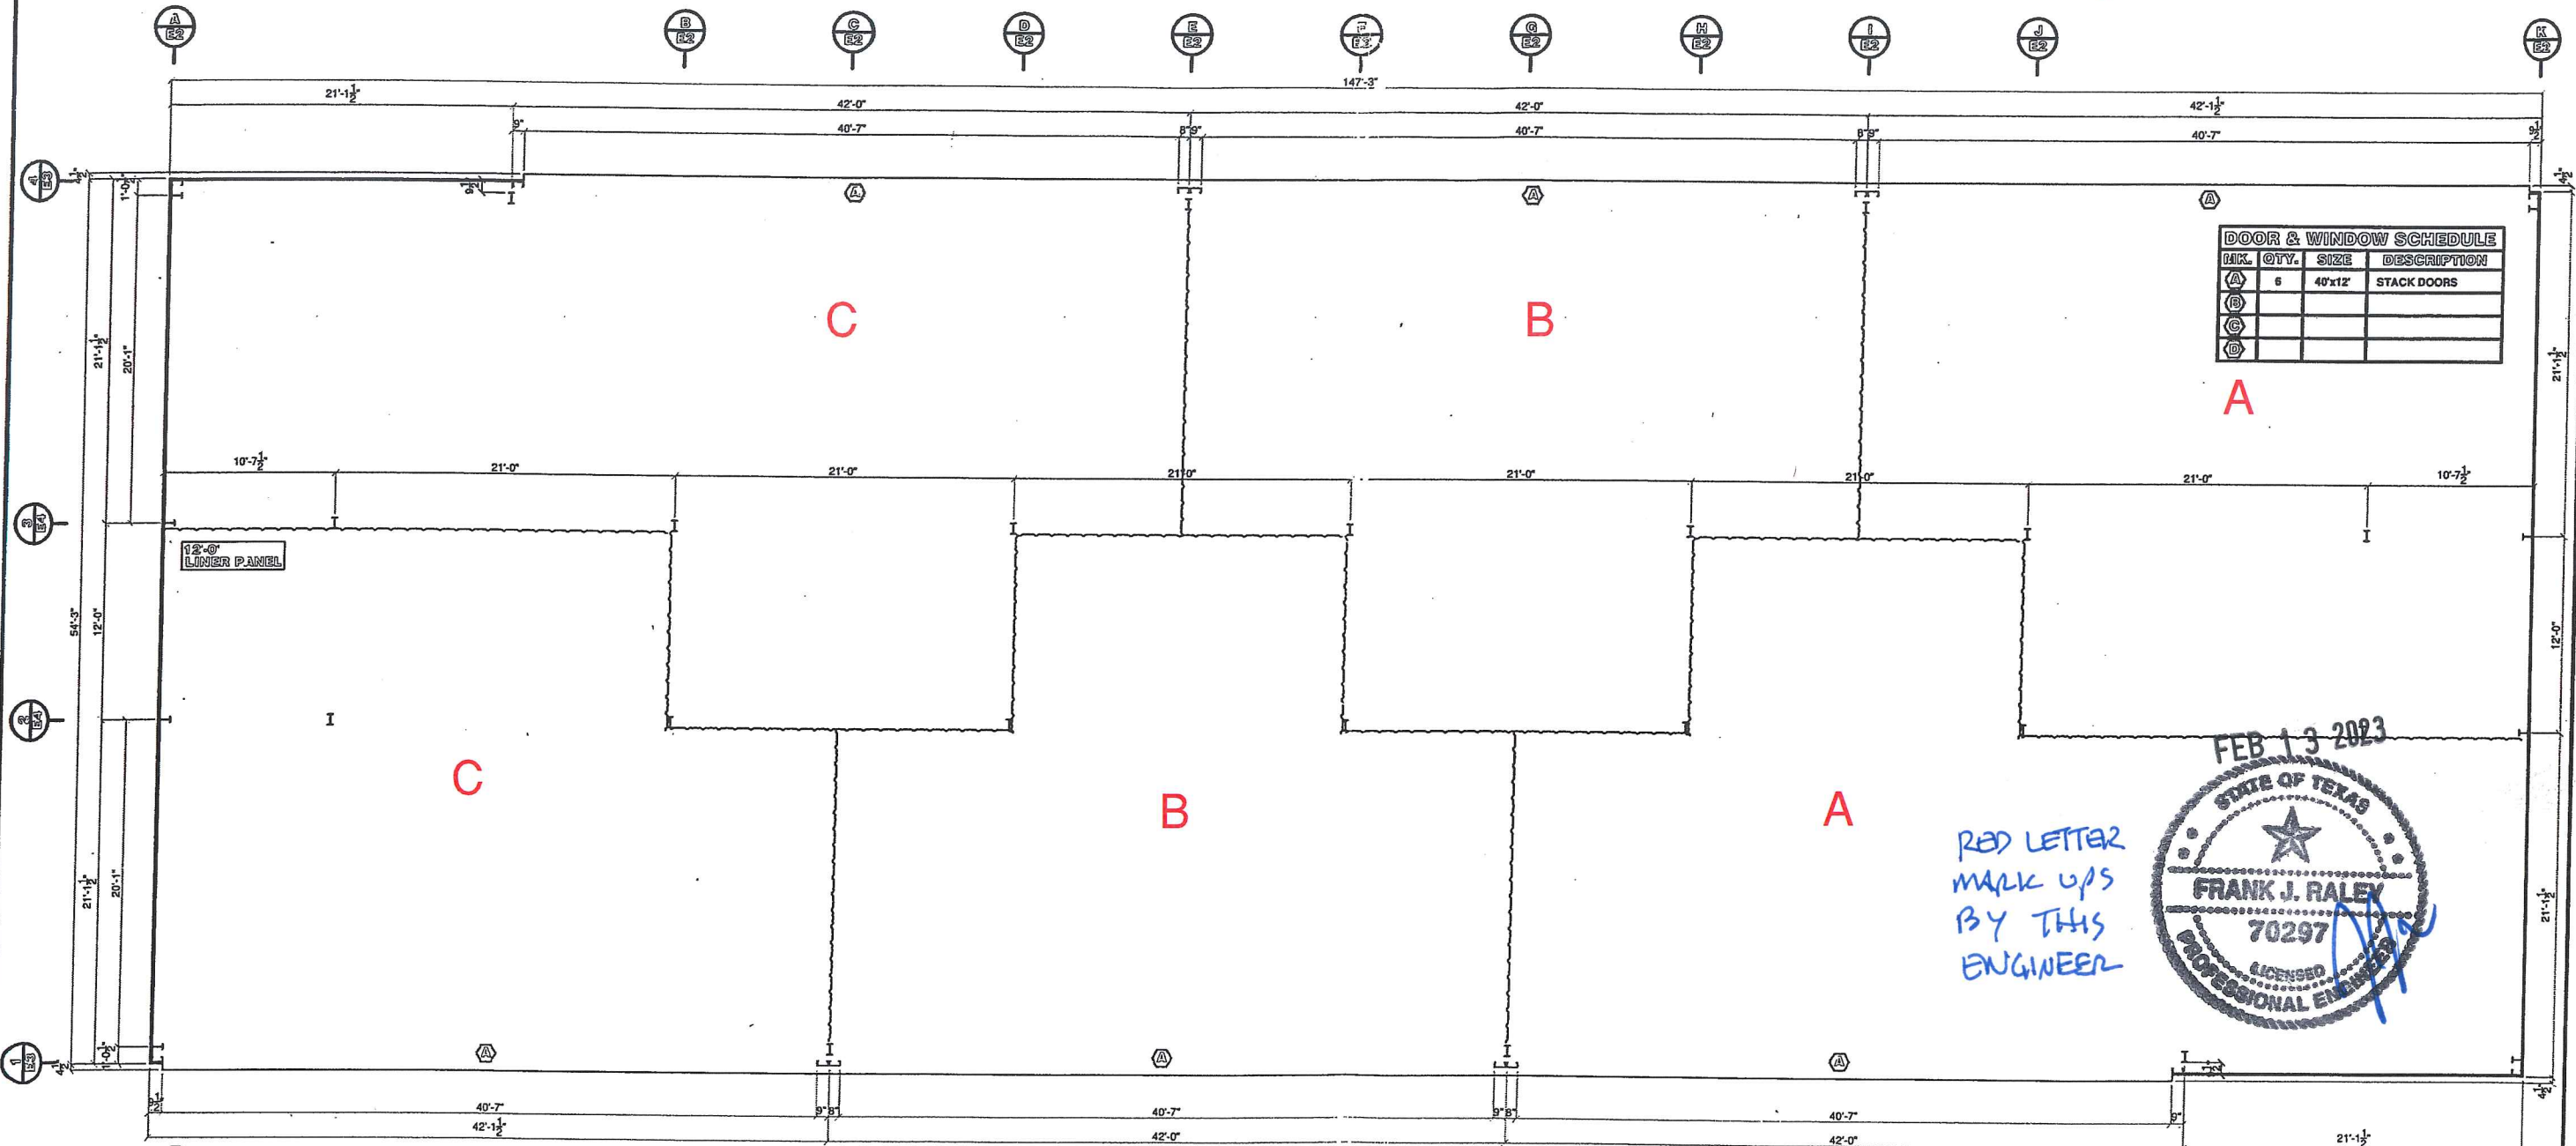
1 COLUMN LOCATION PLAN
D1 R.V.S.

Building 212

Replace the door frames and connection between door frames and main frame columns. The header may be able to be reused.

Replace all door frames, headers, header bracing and connections between door frames and main frame columns

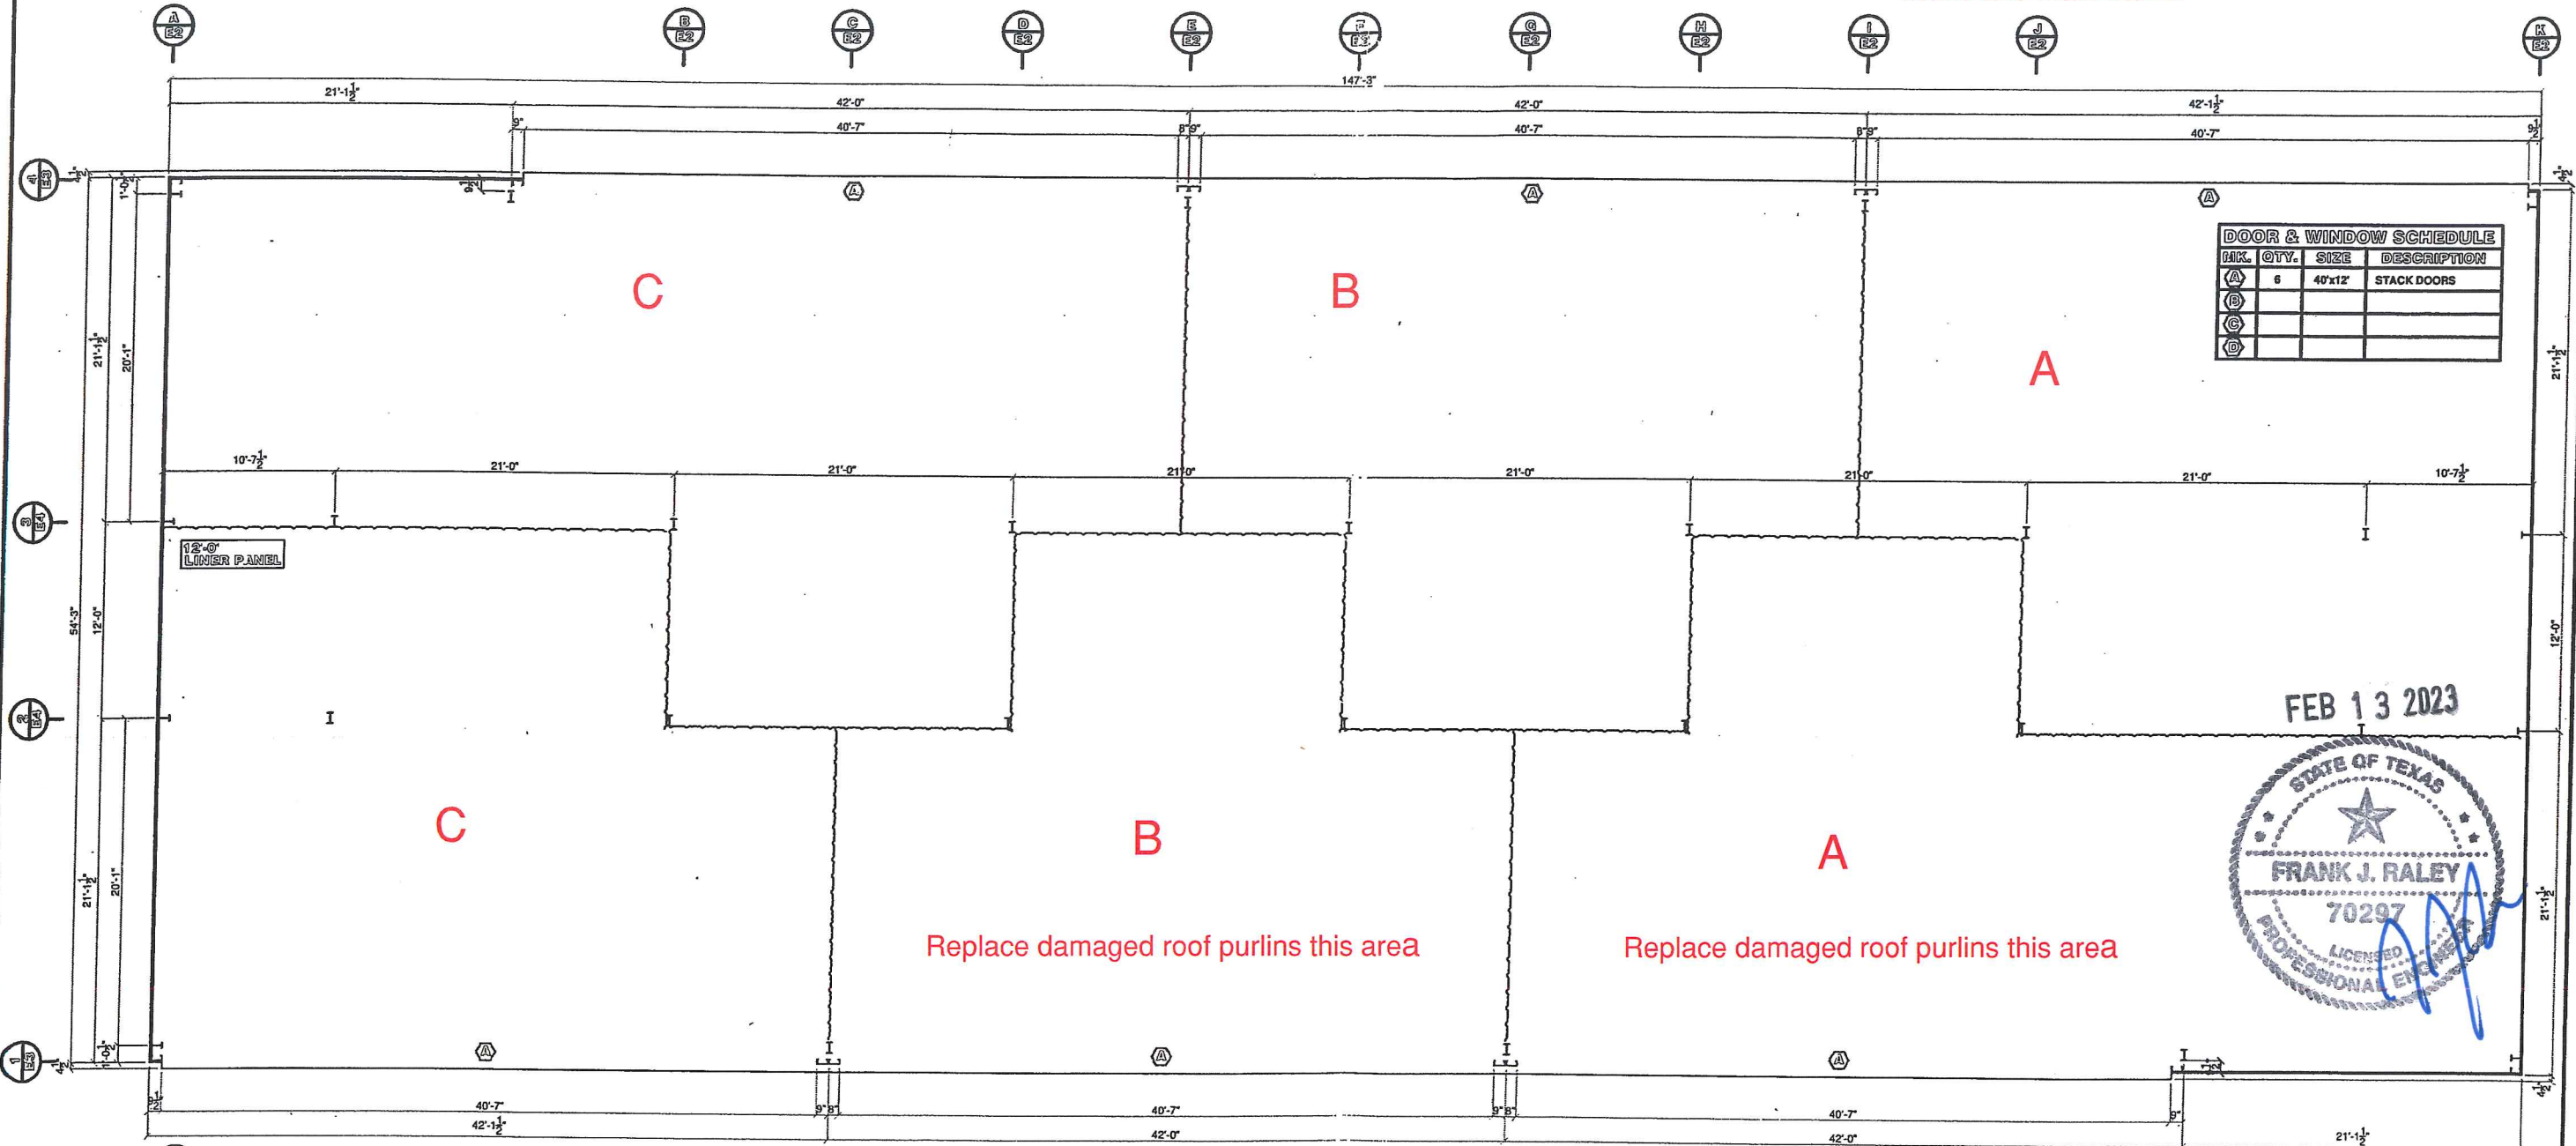
Building 218

Replace the upper door track. Check the header for deformation and replace as needed. Replace west brace at connection of door frame and main frame.

Replace damaged roof purlins this area

Replace all door frames, headers, header bracing and connections between door frames and main frame columns

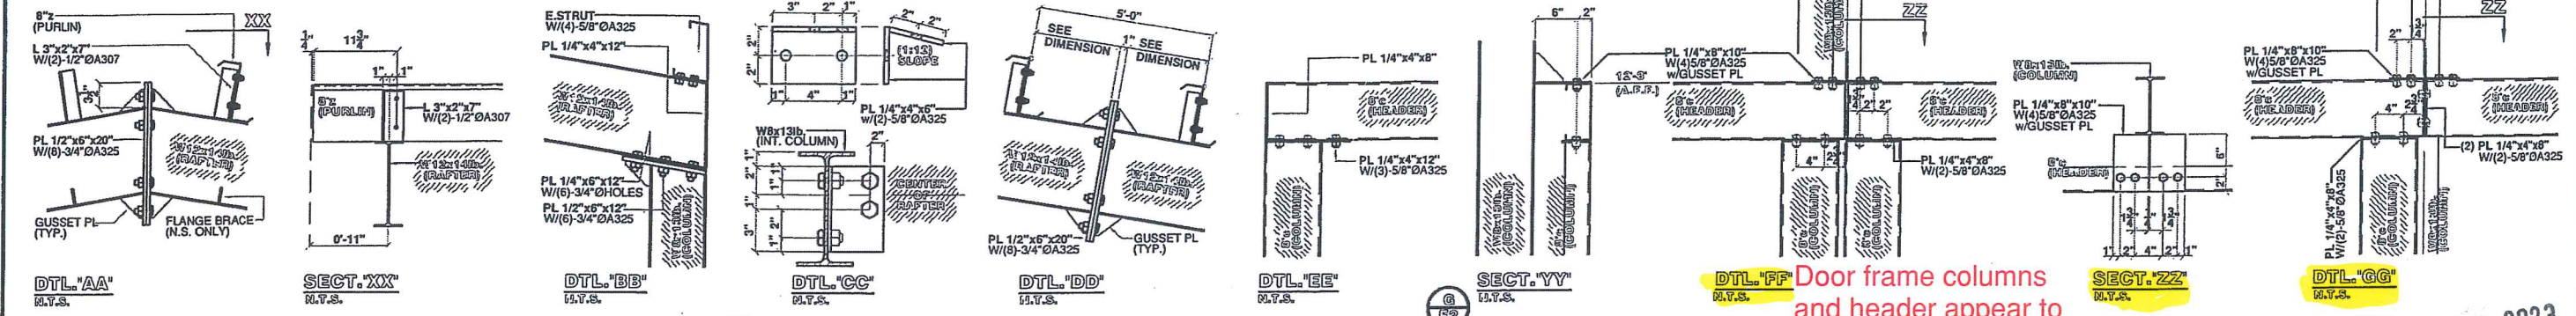
DTL FF Door frame columns and header appear to be 8x3.5x1.5x12ga. Verify in field

Typical header to door frame connection

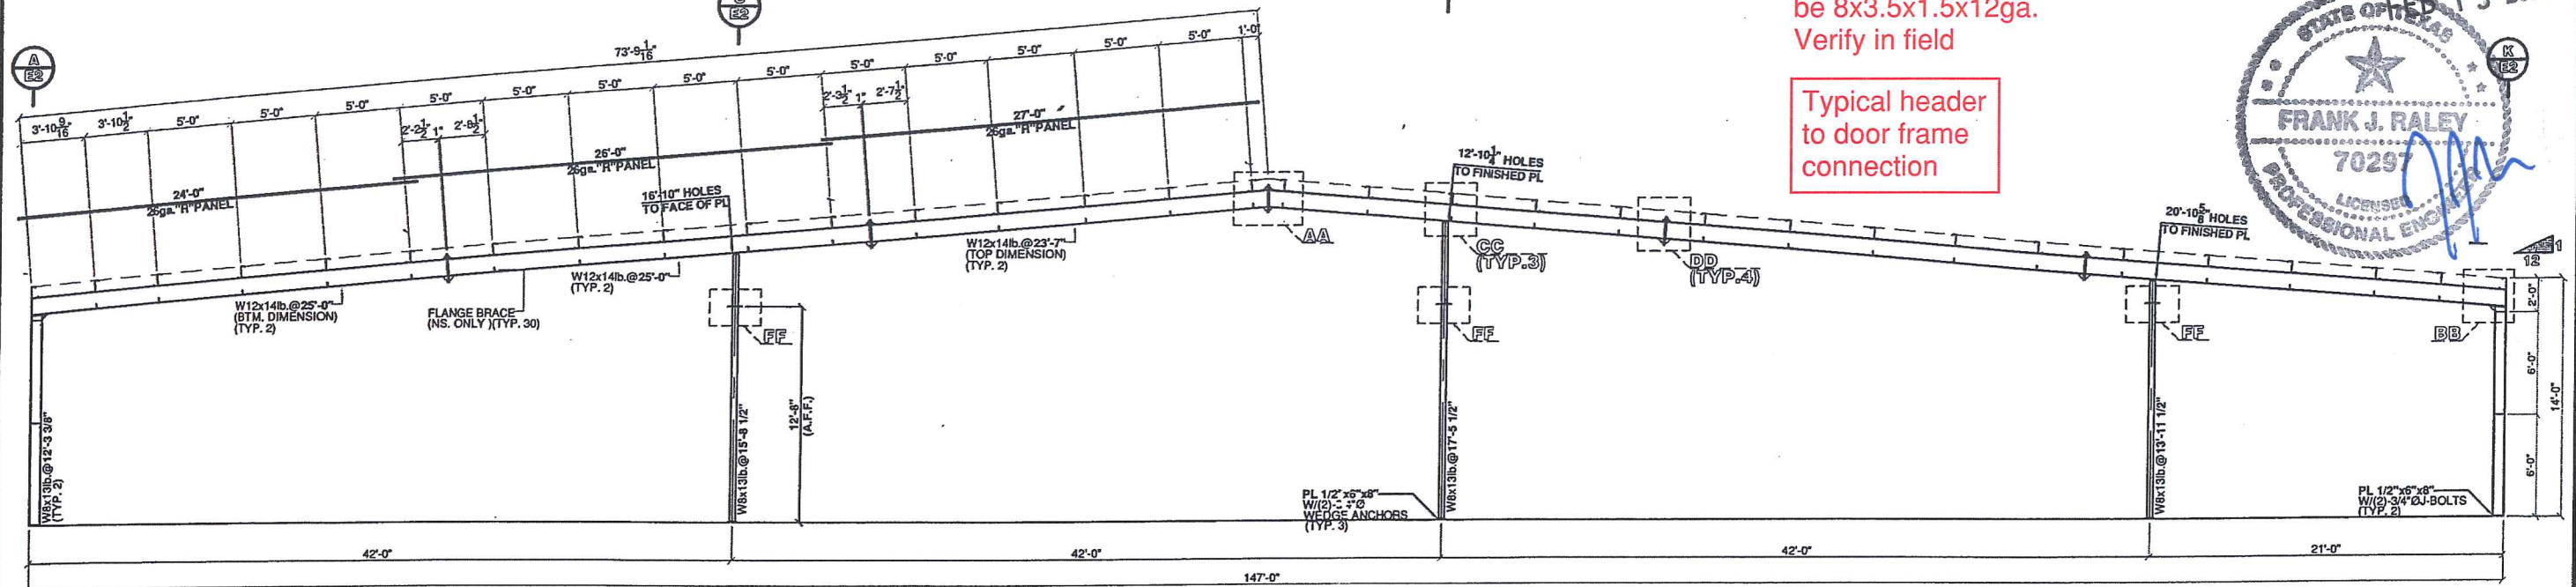
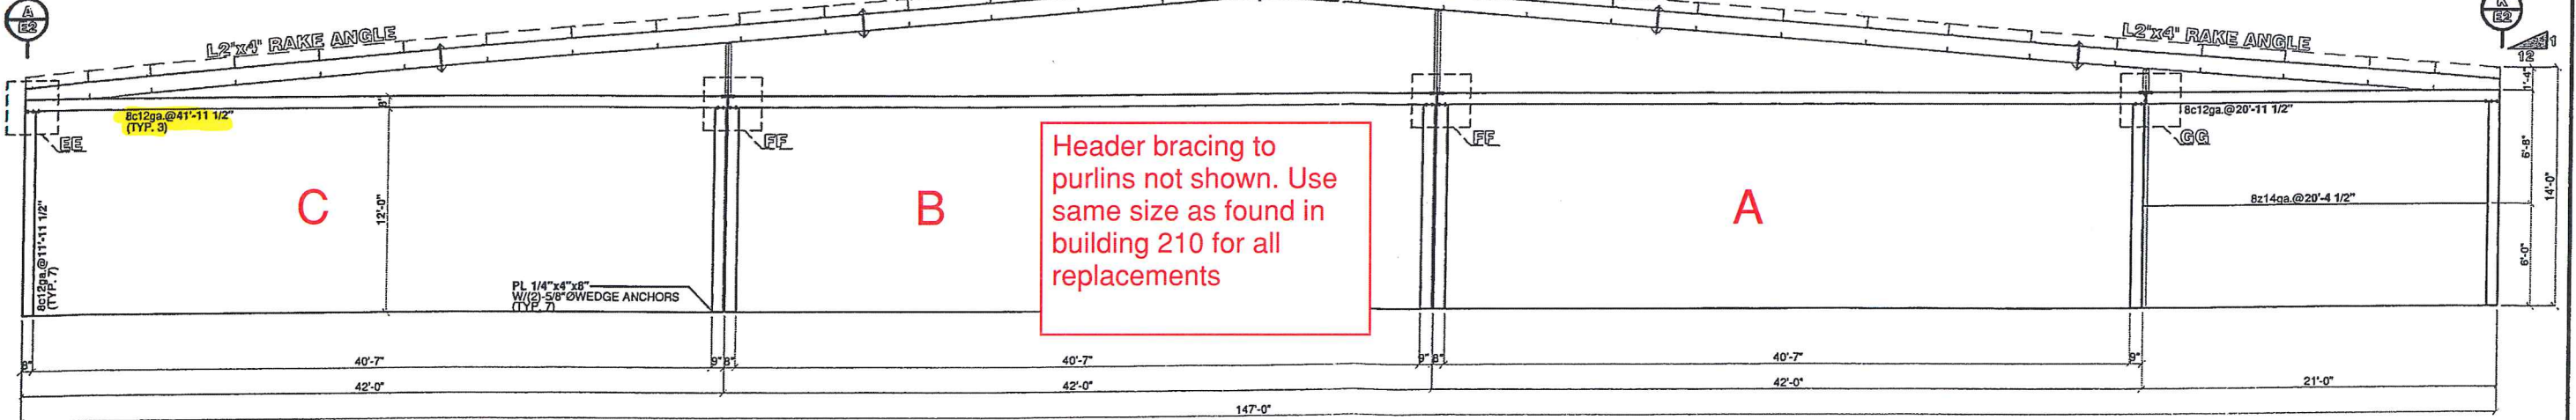
1-4 E.W. @ LINES 1, 4

Header bracing to purlins not shown. Use same size as found in building 210 for all replacements

Verify and replace all damaged siding and trim over and around doors in kind
