INVITATION FOR BID (IFB)

IFB Reference Information:	Sinkhole Structural Repairs		
Insured Property Owner:	Alachua County Library District		
Property Location Name:	Storage Warehouse		
Address Line 1:	3145 NW 43rd Street		
Address Line 2:	Enter Text Here		
City:	Gainesville	State:	Florida Zip Code: 32606

Final Report: Structural Damage Assessment Geotechnical Evaluation

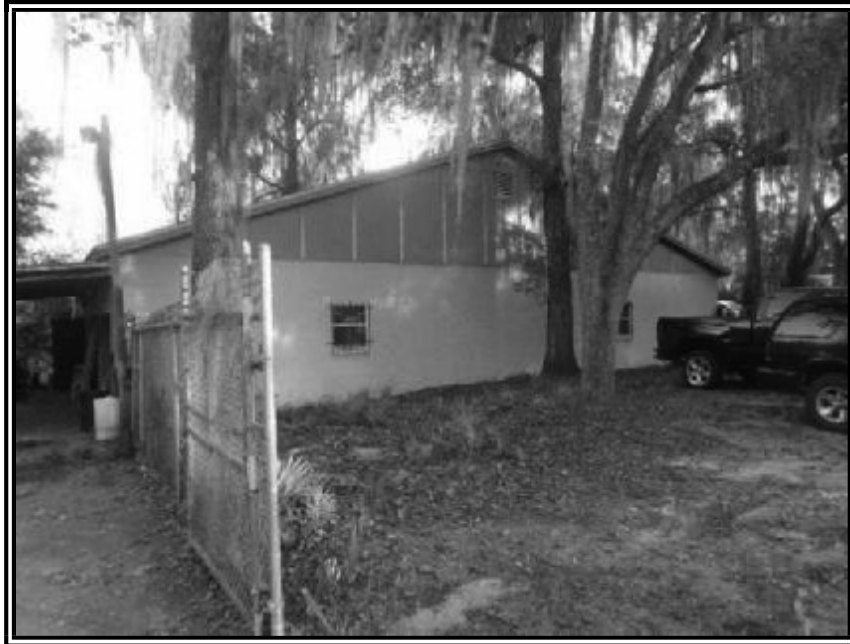
Photograph 1

The Alachua Library Maintenance Building (**photograph 1**) was located at 3145 Northwest 43rd Street in Gainesville, Florida. The parcel's legal description was listed by the Alachua county property appraiser's website as "COM ON E SIDE NW 43RD ST AT SW COR OF NW1/4 POB N 640.60 FT SE/LY ALONG CREEK 521.69 FT N 191.72 FT E 329.36 FT S 664.46 FT TO S LINE NW1/4 W 823.86 FT TO POB LESS THE S 25 FT FOR PUBLIC ROAD OR 459/339 LESS R/W OR 1441/253 & OR 1685/2199 LESS R/W & WATER STG AREA PER OR 1730/1462 LESS WATER STG AREA AS PER OR 1801/0653) OR 1853/2624". The USGS topographic map indicated that the elevation of the site was roughly 153 feet above mean sea level (**photograph 2**).

Front (west) elevation of the Alachua Library Maintenance Building.

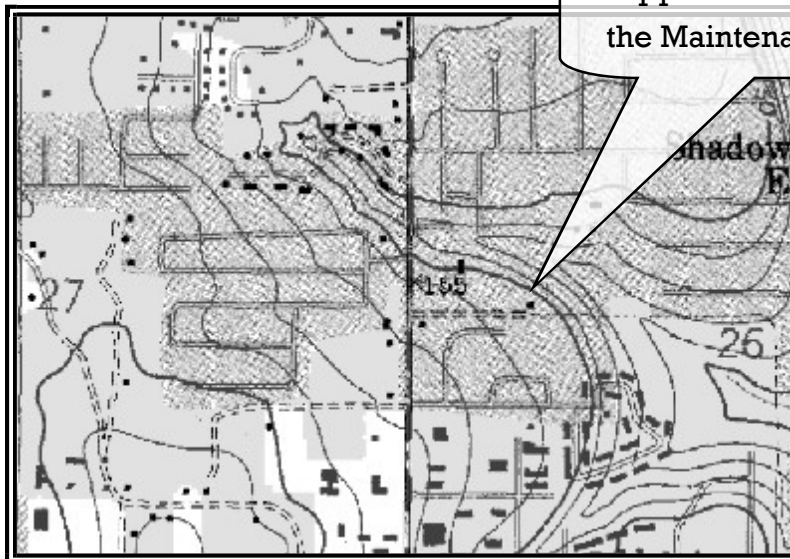
Photograph 2

Topographic map of the property.

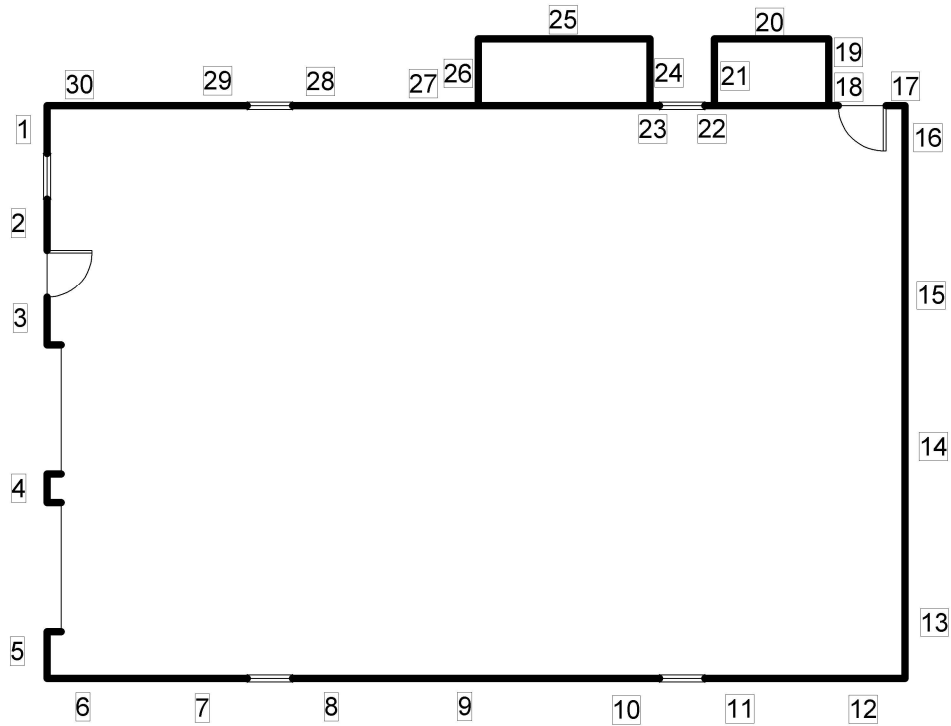
Data Point	Wall Height (feet)	Nominal Wall Thickness (inches)	Maximum Allowable Angle (degrees)	Actual Angle (degrees)	PASS/FAIL
1	10	8	89.37	89.80	PASS
2	10	8	89.37	90.00	PASS
3	10	8	89.37	90.00	PASS
4	10	8	89.37	90.00	PASS
5	10	8	89.37	90.00	PASS
6	10	8	89.37	89.70	PASS
7	10	8	89.37	89.60	PASS
8	10	8	89.37	89.90	PASS
9	10	8	89.37	89.90	PASS
10	10	8	89.37	90.00	PASS
11	10	8	89.37	90.00	PASS
12	10	8	89.37	89.90	PASS
13	10	8	89.37	90.00	PASS
14	10	8	89.37	89.90	PASS
15	10	8	89.37	90.00	PASS
16	10	8	89.37	89.90	PASS
17	10	8	89.37	90.00	PASS
18	10	8	89.37	90.00	PASS
19	10	8	89.37	89.60	PASS
20	10	8	89.37	89.70	PASS
21	10	8	89.37	89.70	PASS
22	10	8	89.37	89.70	PASS
23	10	8	89.37	89.80	PASS
24	10	8	89.37	89.70	PASS
25	10	8	89.37	89.80	PASS
26	10	8	89.37	89.70	PASS
27	10	8	89.37	89.90	PASS
28	10	8	89.37	89.90	PASS
29	10	8	89.37	89.80	PASS
30	10	8	89.37	90.00	PASS

Note: Allowable wall angle taken from horizontal axis in decimal degrees.
